iR 5065/5075's EO61 관련

Canon

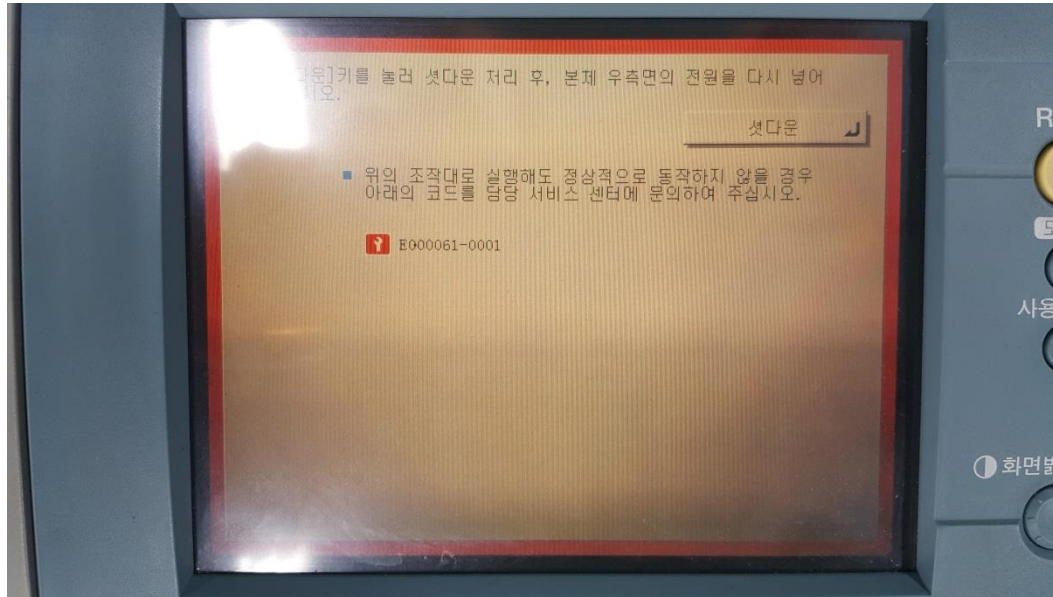
상기 이미지와 같이 기기 구동 시 E061-0001이 발생

※ 발생시 기 조치법: DC-CON교체, 레이저 교체, 대전기 교체, 전위센서 교체

커버[FL2-5834] 혹은 팬덕트 ASSY[FM2-9694] 교체

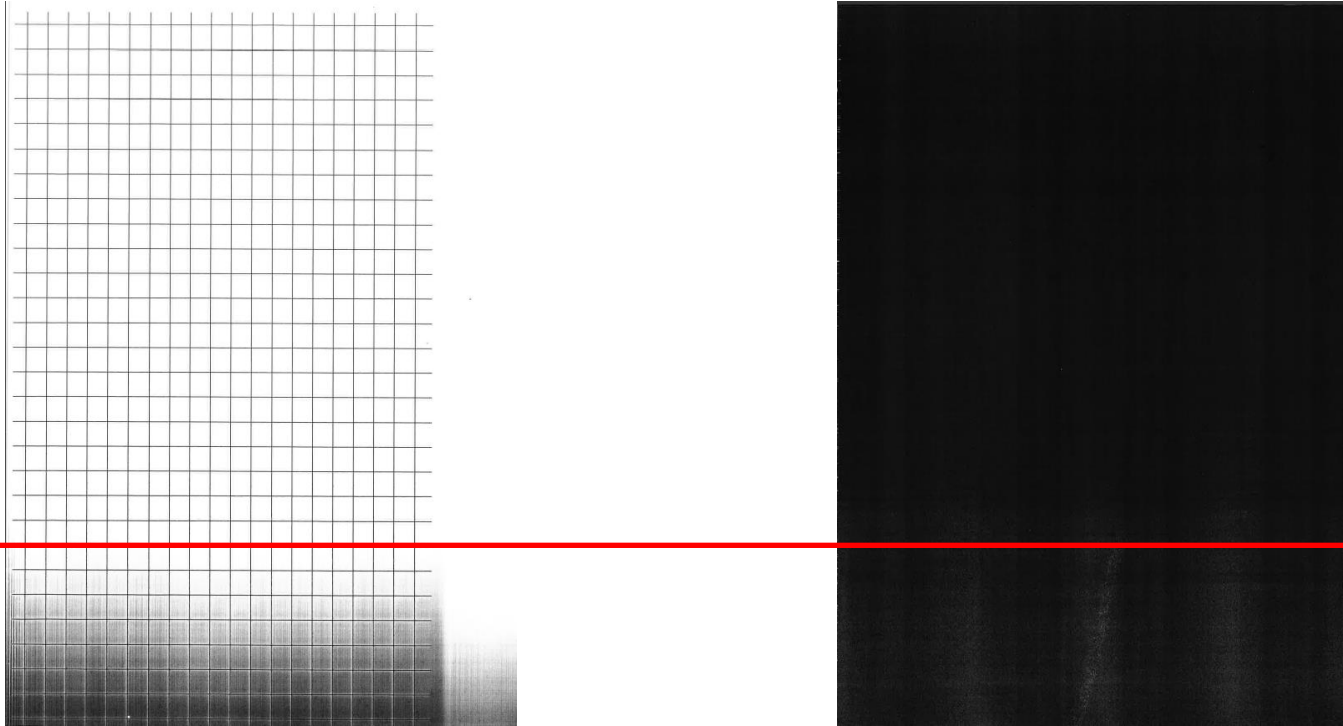
구동 시 에러 발생 하지 않았을 때는 출력/복사 시
상기 이미지와 같이 하단부 이미지 불량 하며 E061 발생

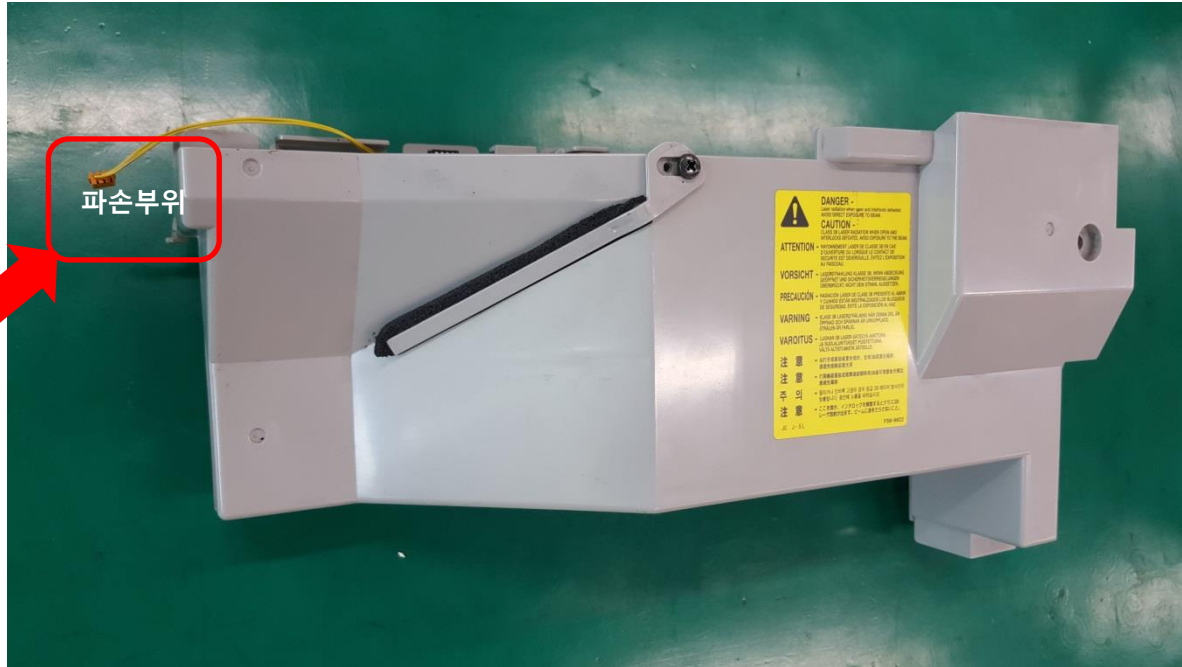
팬 덕트의 왼쪽 나사 체결부 파손으로 덕트가
완전히 고정 되지 않은 상태에서 사용 시 발생

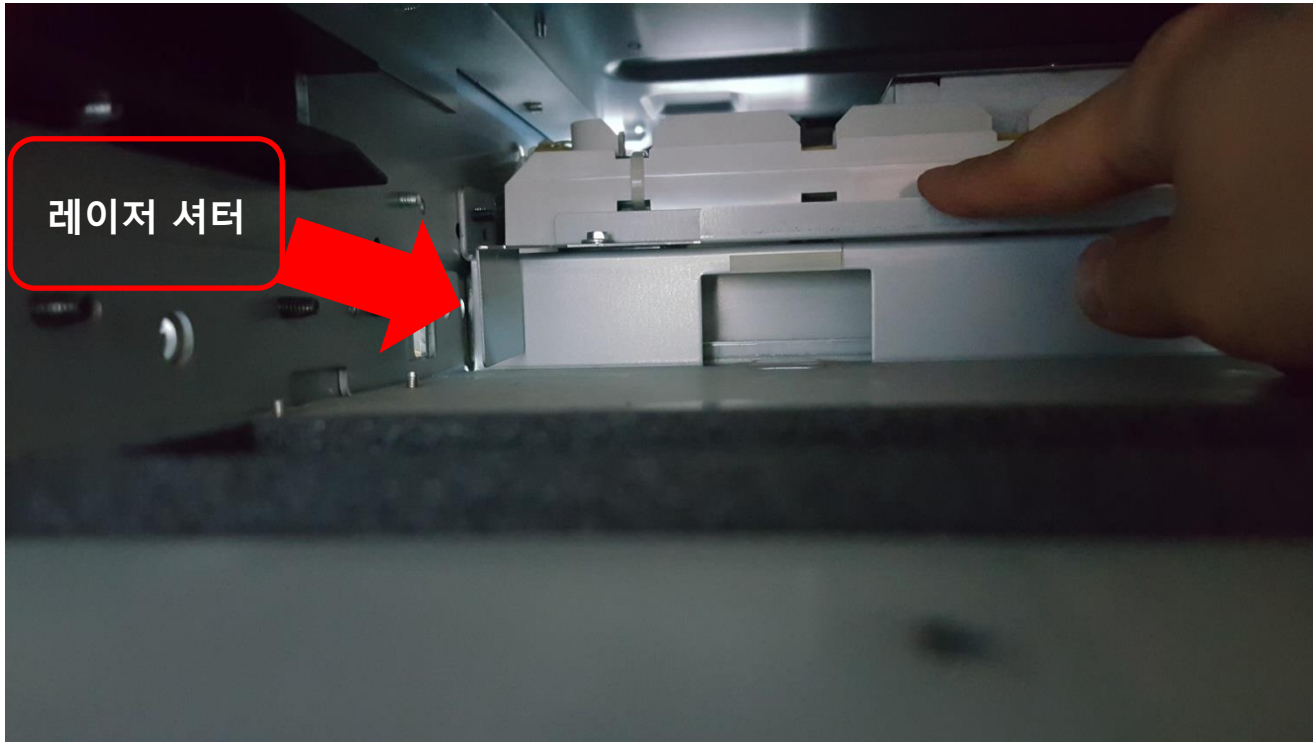
팬 덕트가 고정되지 않아 파손부 뒤쪽의 돌출부가
기기 내부의 레이저 셔터를 눌러 주지 못하며 발생.
