# VP140 해결 사례 공유

Ver 23.11 SF

PS지원담당

23. 11. 05

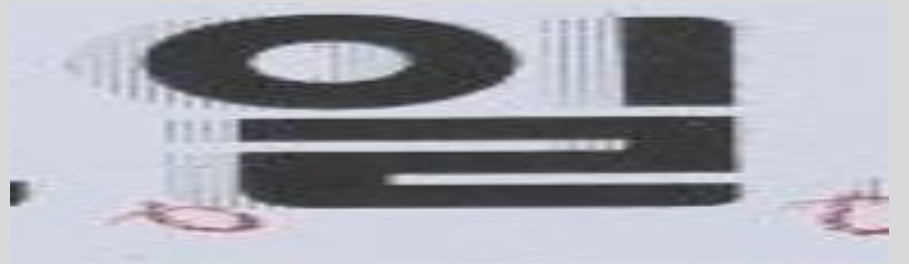
6, 스캔 사용시 화상 불량  
(화상 합성, 음영 발생)

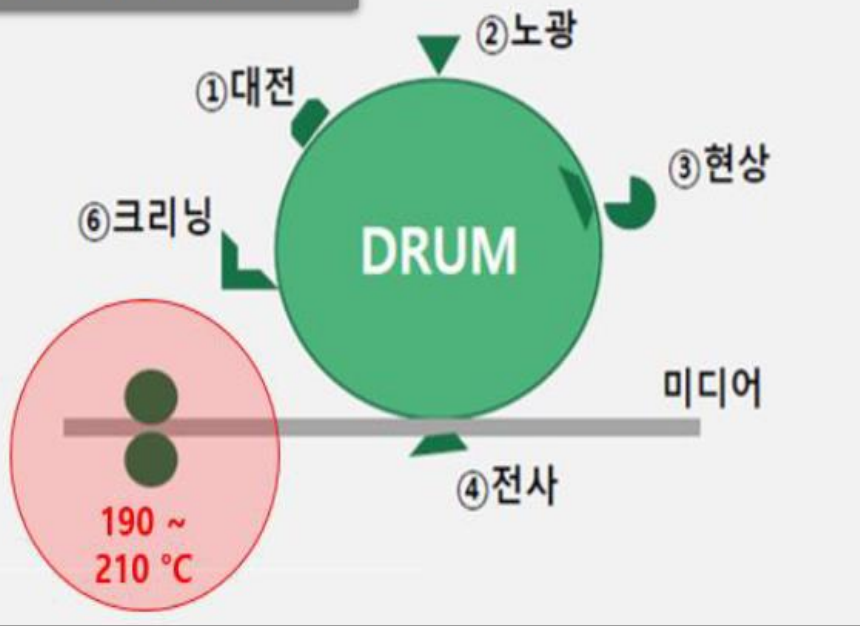
### 전사사진 인쇄방식

- 대부분의 출력장비 인쇄 방식
- 구조적으로 복잡함
- 정착 영역(열원) 분리
- 높은 정착 온도 (190~210 °C)사용  
> Wax가 정착 중 기화 배출

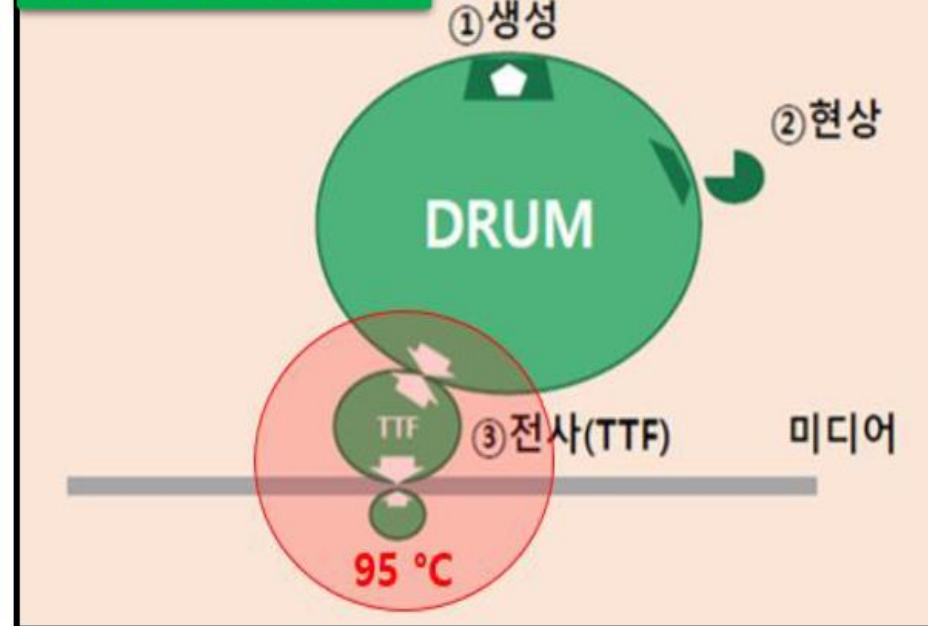
### Direct Press 인쇄방식

- VP-DP 인쇄 방식
- CPP만의 독자적 인쇄 기술방식
- 오존 발생 없고 소량의 폐기물 발생
- 정착 영역(열원)과 맞물려 돌아감
- 낮은 온도의 정착 온도 (95 °C)  
> WAX 흡수 제거 / 대기기간 기화 제거

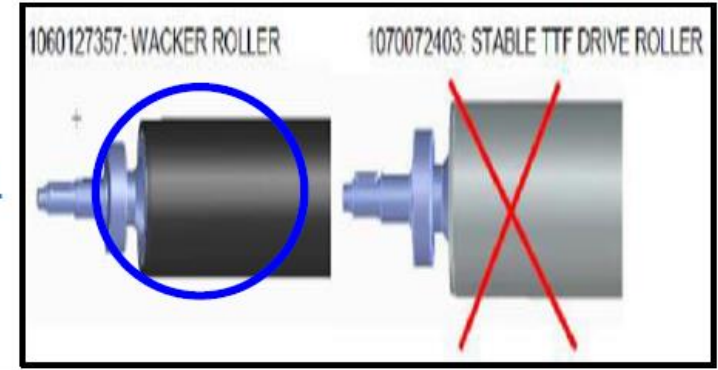
신규 설치 기기

- 신규 장비 설치시 ROLLER DRIVER 클레임 교체

=> 신규 장비는 WAX 제거 기능 없는 롤러 장착 출고  
ROLLER DRIVER (1060127357) 로 필수 교체

- 신규 기기는 ROLLER DRIVER (1060127357)  
장착 되어 있지 않음.

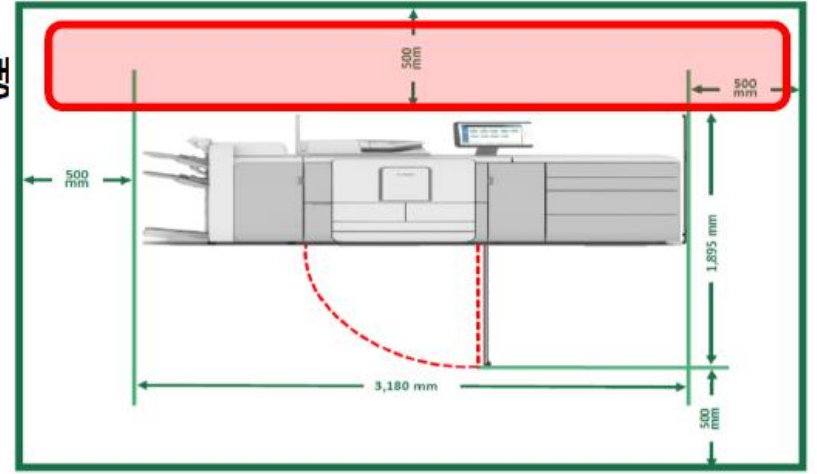
## 환기 불량으로 WAX 증상 발생 사례

- 기기 내부 배기 불안정으로 심각한 WAX 증상 발생  
>기화된 WAX가 원활히 배출이 되지 않아 기기 내부에 정체, 냉간시 액상, 또는 고체 상태로 기기 내부에 출력 화상 불량 발생
- 기기 후면과 벽면 50Cm 이상 환기 공간 확보
- 후면 FAN (1060080221) 정상 작동 확인 여부
- 환기 공간 확보 후 증상 없어짐

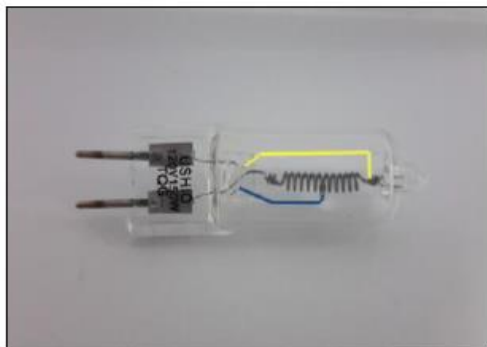
①

### (1) 램프 사전 확인

- 노란색 부분 : 전기 회로 내 Return wire
- 파란색 부분 : Support wire

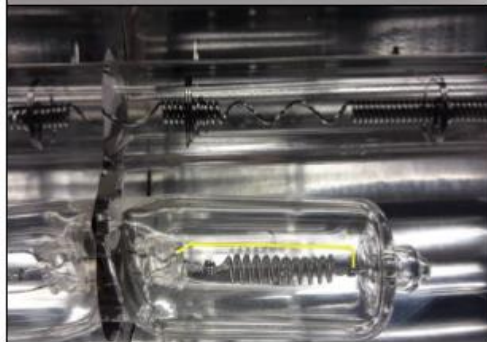
②

### (2) 장착 전 램프 확인

- 노란색 부분이 HOD 램프를 향하도록 세팅.
- \* 반대가 될 시, 램프 내 필라멘트가 쉽게 파손될 수 있음.

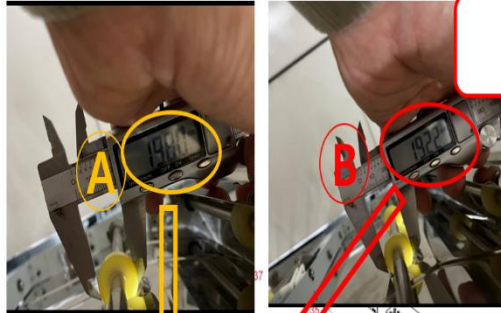
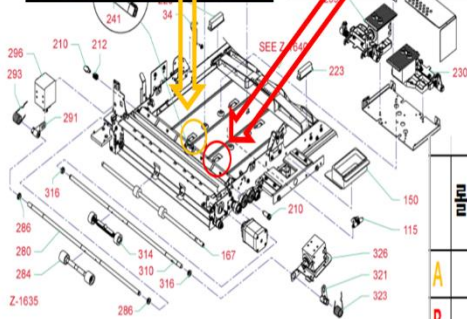
Simplex skew 발생원인  
Tray2 JAM 16705

롤러 지름	롤러 둘레	롤러 차이발생	A4 출력시 롤러간 오차
A 19.8	62.172	-1.8212	6mm이상
B 19.22	60.3508

롤러 편마모에 의한 Jam 발생 본체 1,3,4 번 용지함 정상 출력  
2번 용지함 유독 심한 발생, E-pim 간헐적 발생

표기된 해당 롤러 Part No. 1070061513 2EA 교체

ROLLER, CPL 1070061513 2EA 교체, 동일롤러 편마모 체크

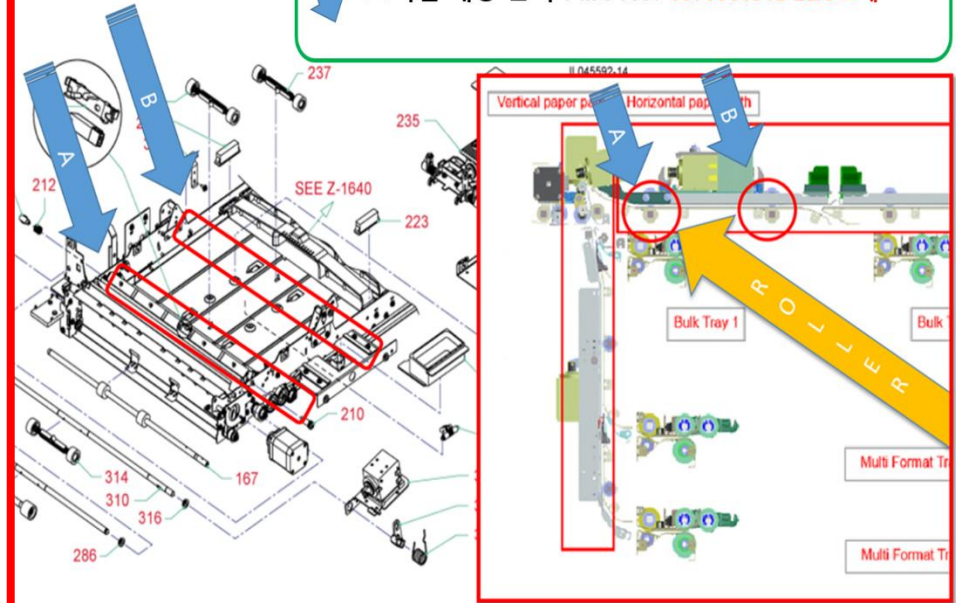
# 16705 Skew jam

증상

해결

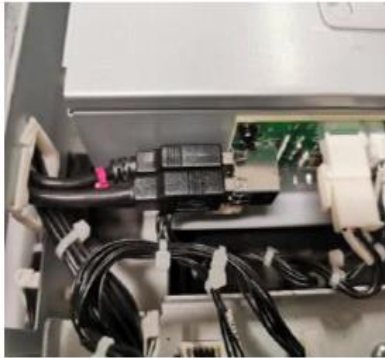
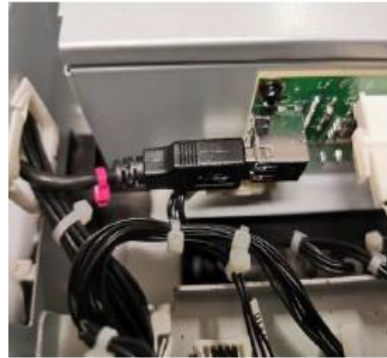
1. Top 커버 제거 (컨트롤러 위 커버)
2. 붉은 케이블 타이가 묶이지 않은 USB Cable 분리 (컨트롤러 내 마더보드에 위치)
3. 붉은 케이블 타이가 묶인 USB Cable을 아래 사진과 같이 장착

기존

변경 장착

증상	초기 부팅 후 모니터 화면이 깜빡 거리는 증상
해결	USB Cable 위치 변경

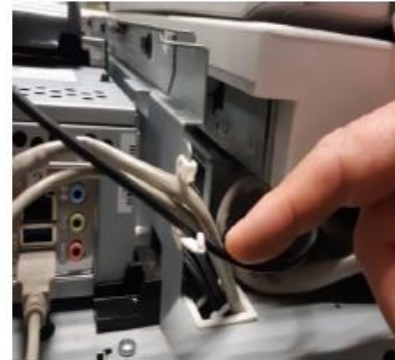
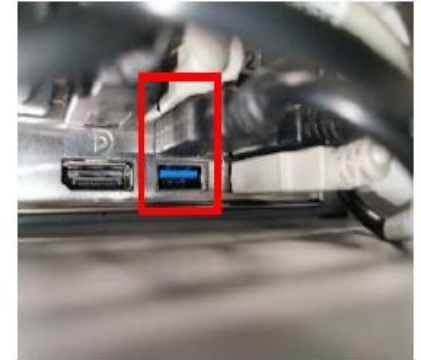
4. 케이블타이가 묶이지 않은 USB Cable을 컨트롤러 뒤로 위치
5. 아래 사진과 같이 Cable 정리
6. 케이블타이가 묶이지 않은 USB Cable을 USB 3.0 포트에 장착

Cable 정리

USB 3.0 포트 (컨트롤러 뒷면)

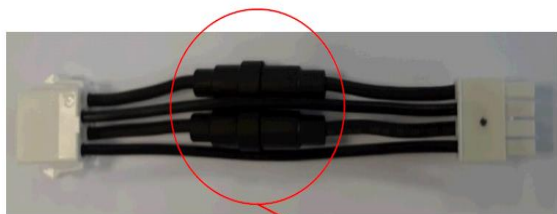
Harness, 22W50  
1070108847

- 초기 부팅 시, 기계 Warming-up 중 E6506 발생, 달 버튼 누를 시, E25701과 함께 E6507 발생.

- HOD 램프 필라멘트 단선과 동시에, PSU와 HOD 사이 신규 케이블 내 퓨즈 단선.

신규 케이블 내 퓨즈 단선 (동통 테스트 필요)

- 22W50 케이블 제거 및 교체 : 22W50 케이블 제거 시, 정상 부팅 가능.

→ 케이블 재고 부재 시, 제거 후 HOD 연결 케이블 PSU에 장착. (임시 방편)

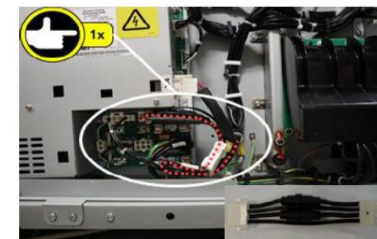
(2) PSU 내 신규 케이블 운영 (신규)

No.	부품 번호	부품명	비고
1	1070108847	Harness, 22W50

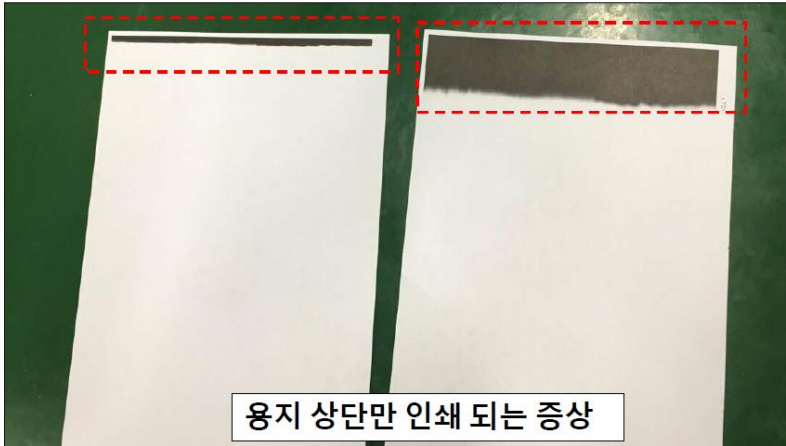
### 1. 용지 상단만 인쇄(화상불량)

- 증상 : 출력 시 드럼unit이 TTF 벨트 분체 후측에만 닿아 용지 윗부분만 출력되는 증상 발생
- 해결방법 : Warm Process 커버 조립 불량으로 인한 화상불량 발생  
 <첨부1> 처럼 정상 장착될 수 있도록 커버 쇠판을 원래 상태로 구부려서 해결

증상	크리너 교체 또는 워유닛 분해 수리후 화상 불량 발생 드럼 표면과 TTF BELT 접촉면 간섭으로 인한 발생
해결	별첨 2 불량 부분 변형 / 수정하여 처리 완료 (백지 발생 또는 상단 만 인쇄, 구동시 드럼표면에 화상은 정상적)

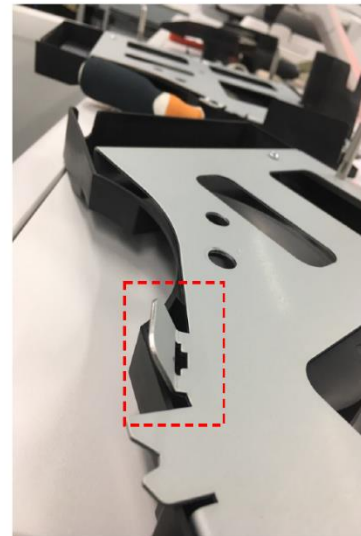
<정상>

### 별첨2. 커버 쇠판 확인

- Warm Process 커버 철판이 변형되어 조립 불량 발생

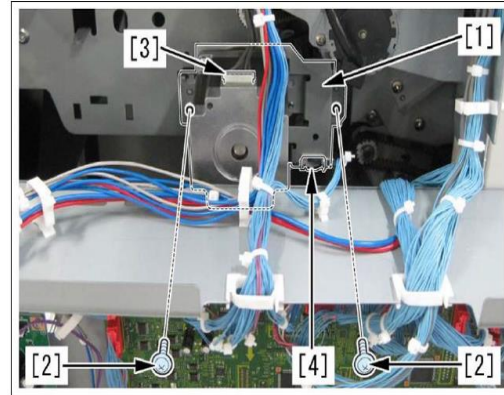
[1]디스포즈 모터(M26)와 [2]디스포즈 샤프트 사이의 벨트 장력이 느슨해지면  
간헐적으로 용지걸림 E1870238 발생 (약 1천~2천장 사이)

## - 구동 모터 간격 조정

### <분해 수순>

- [3]: 모터 커넥터 제거
- [2]: 나사 2EA 제거
- [4]: 결쇠 분리
- [1]: 드라이버 유닛 아세이 제거

### <조정 방법>

- [1] 나사 2EA 느슨하게 풀고
- [2] 화살표 방향으로 모터를 최대한 이동시킨 후 [1] 나사 체결

증상	타이밍 모터와 샤프트 동력 전달 과정 중 타이밍 벨트 늘어남에 따라 모터와 샤프트 풀리 사이에 동력 손실 발생 (타이밍 이탈) 간헐적 Jam 발생
해결	모터 고정 나사 제거 후 타이밍벨트 장력 조절

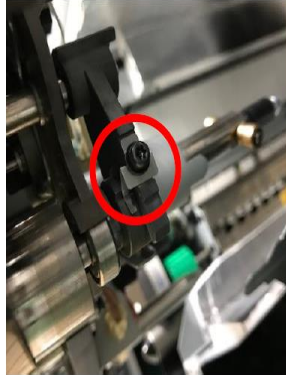
- 출력 수직 방향, 약 9~10cm 간격으로 백선 발생 (아래 사진 참조)

→ TTF Unit 내 Leaf spring 파손 여부 확인 **必**

### 2. 교체 품목

TTF Unit WPR, 0670

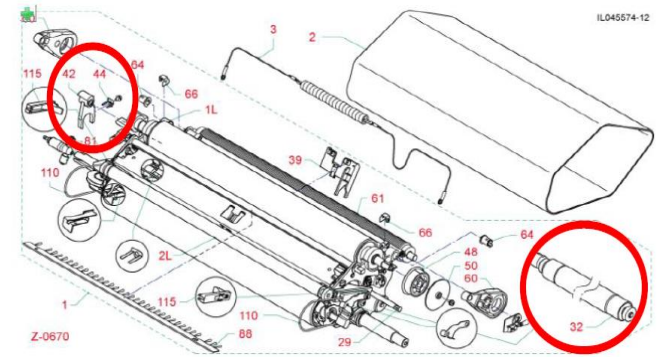
- (1) 44번 부품 : SPRING-LEAF / 1060080698
- (2) 42번 부품 : LEVER-JITTER-ASSY / 1070064648 - 필요 시 교체, 반드시 32번 부품과 함께 교체
- (3) 32번 부품 : TRANSFER ROLLER CPL / 1070089066 - 필요 시 교체, 반드시 42번 부품과 함께 교체

증상	화상 불량 백선 발생 (그레이, 블랙 출력시 확인 가능)
해결	화상 축소도 동반하는 경우가 있으니 확인 필수!

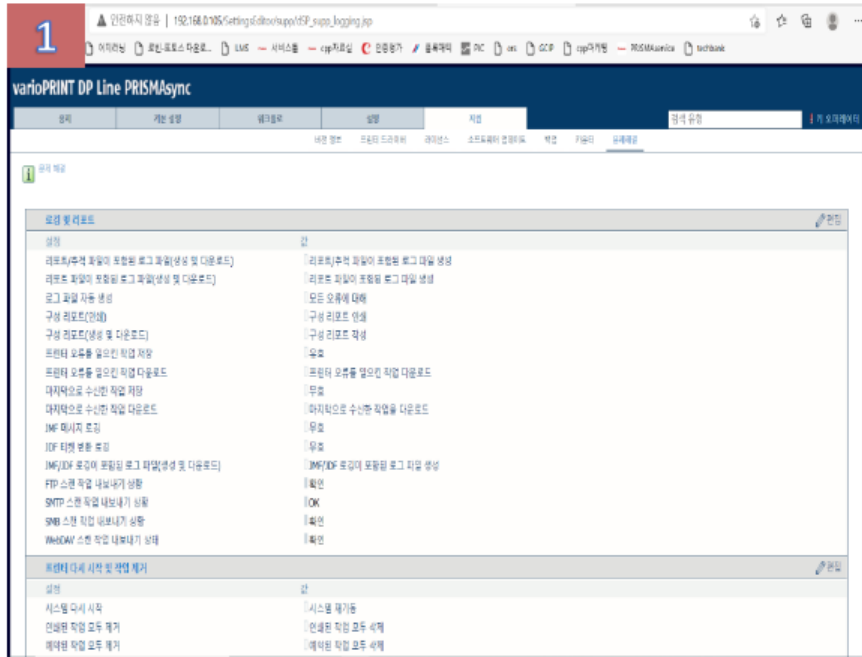
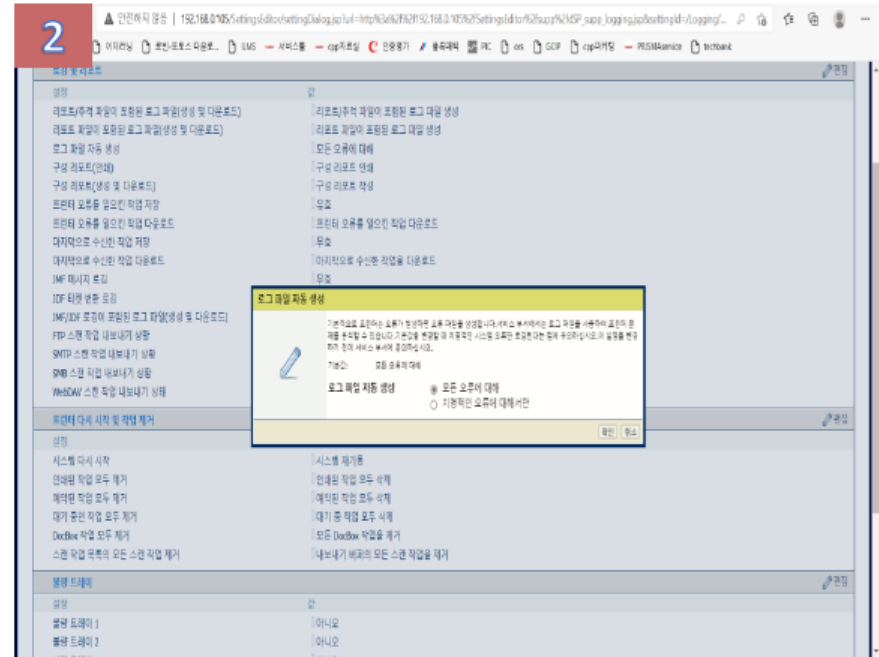
(1) Setting editor 내 지원-문제해결-로그 및 리포트 접속.

(2) 로그 파일 자동 생성 클릭 후, '치명적인 오류에 대해서만' 설정.

증상	R 6.2.3 Ver 이상 에러 발생시 소요 시간 증가
해결	에러 발생시 자동 로그 취득으로 해제 설정

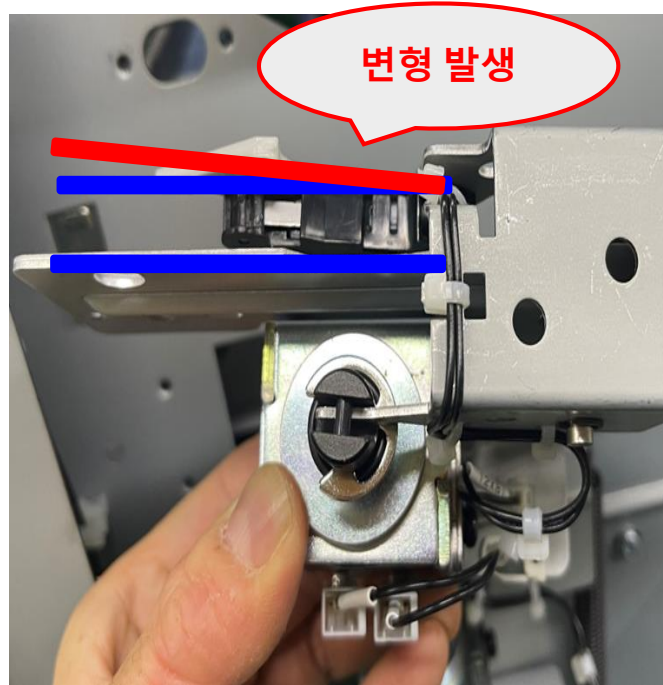
Paper Tray Lock Assy, 1296

부품 변형 발생

증상	간헐적인 트레이 열림으로 인식 (간헐적)
해결	TRAY LOCK 변형으로 인한 마이크로 스위치 접촉 불량 부번 <b>1070023495</b> (PIM TRAY LOCK ASSY) 교체 또는 조정 필요

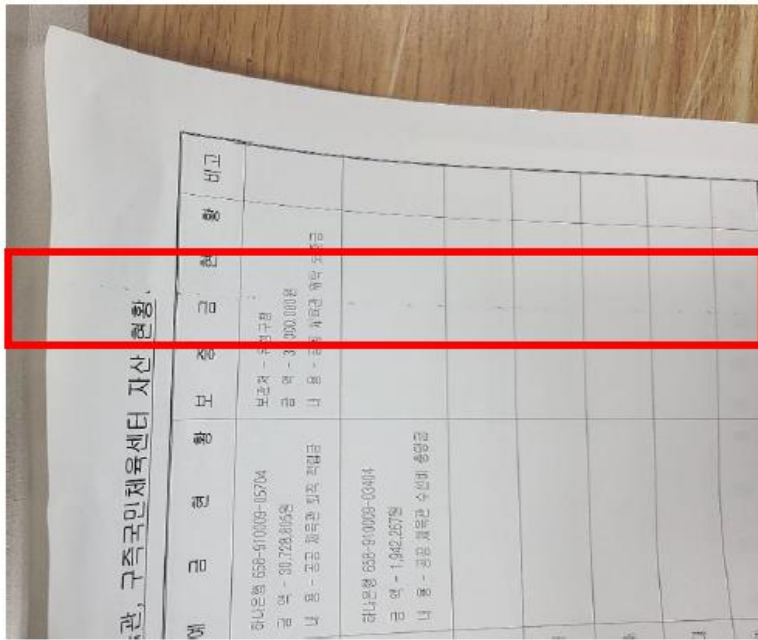
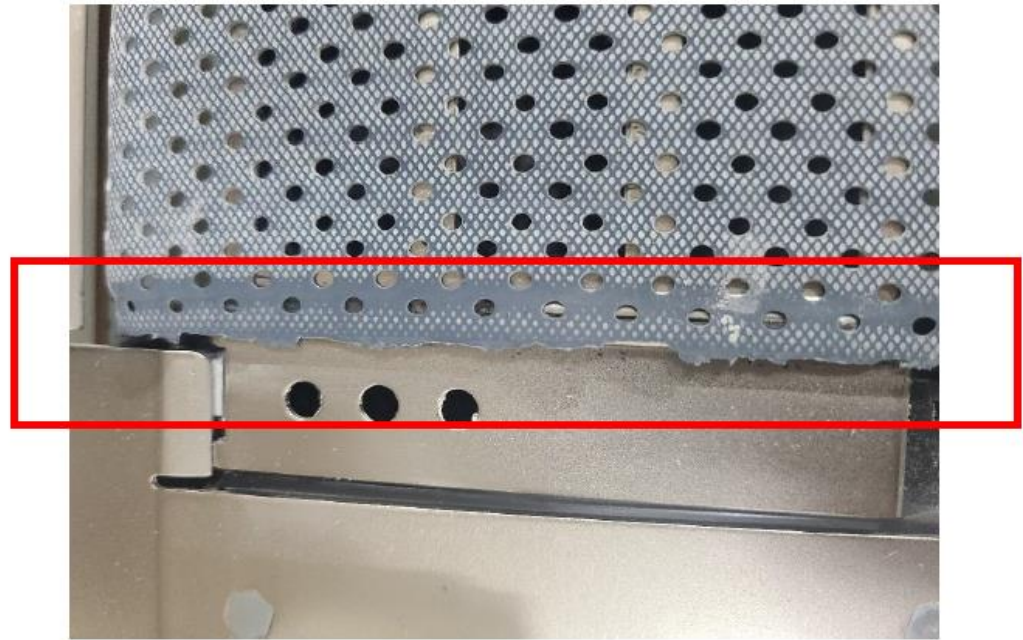
<화상 불량>

- 용지 진행 방향으로 간헐적 화상불량 발생(특정 위치)
- 글루 성분이 묻어 나오는 것 같은 불규칙 화상불량 발생
- 본체 카세트 출력시에는 발생안하나 E-PIM 출력 시 해당 증상 발생

<불량 부품>

- E-PIM 급지 벨트 치우침으로 프레임에 고무가 갈려 고무 성분이 용지에 전달
- 간헐적으로 증상이 나오며 정확한 확인을 위해 급지부를 탈착하여 확인 필요
- BELT, SEPARATION 교체(1070113524000)

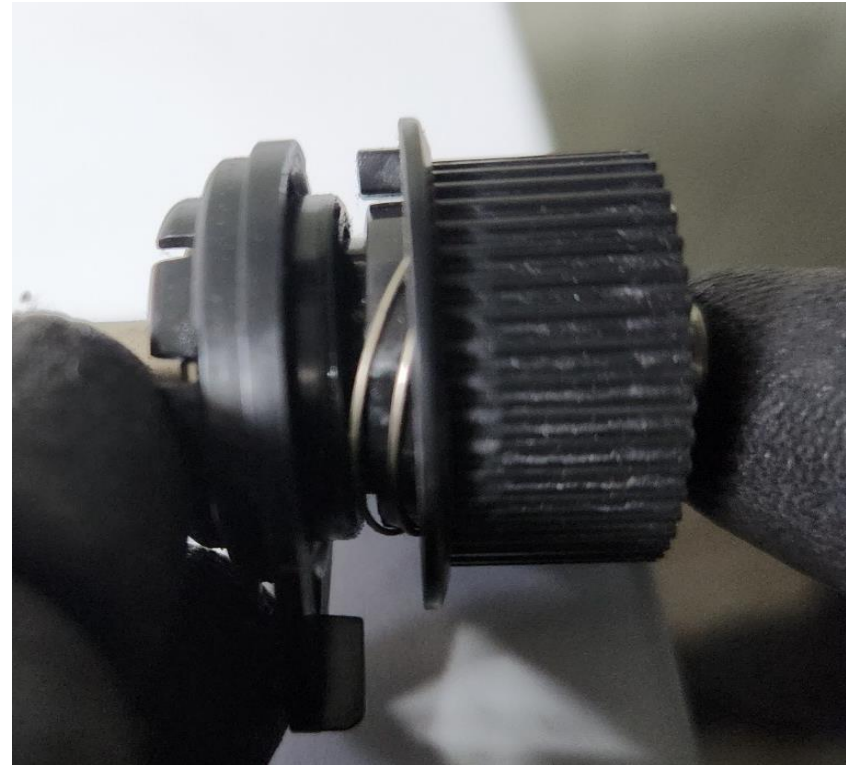
IL074:

Index	Part no	Qty	Description
1	1070086118	3	ROLLER ASSY
4	1060098009	2	PULLEY,TIMINGBELT-45 2MR
5	1060123640	1	PULLEY-CLUTCHED, ASSY

증상

인쇄면이 위로 출력시 3장 나오고 jam 발생

1060123640 PULLEY-CLUTCHED, ASSY 교체

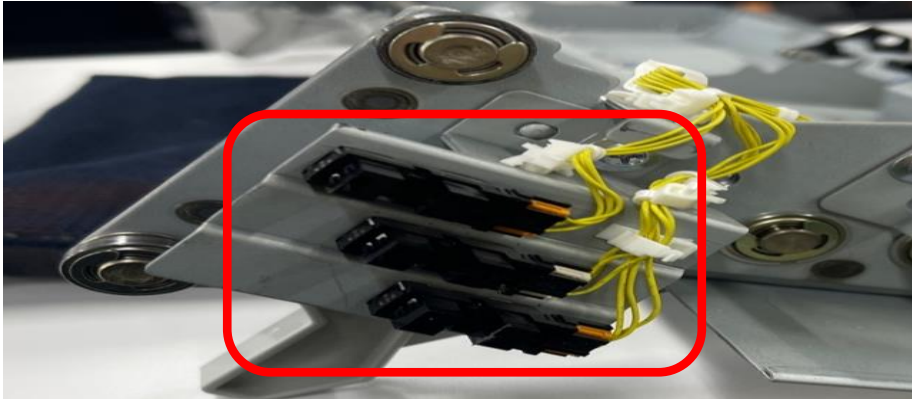
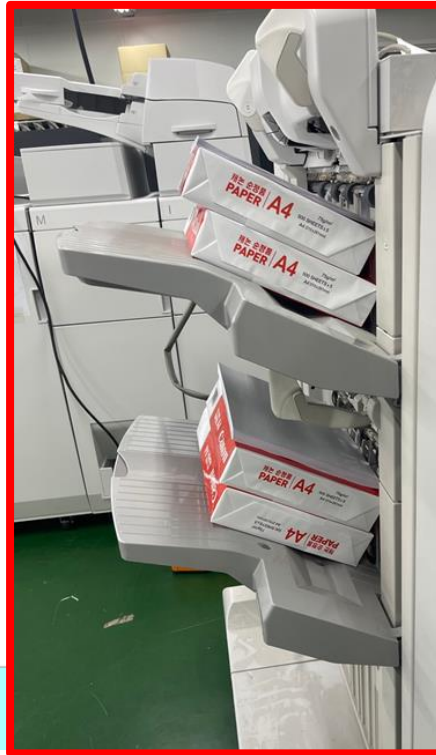
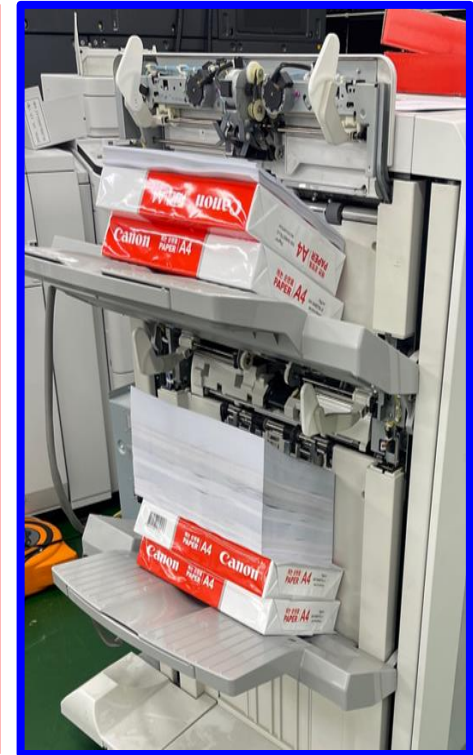
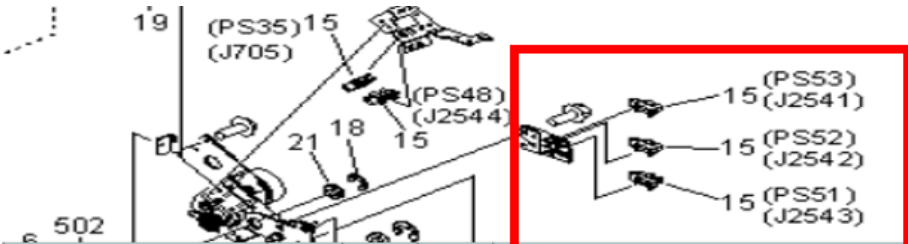
WG8-5848-000	3	IC, PHOTO-INTERRUPTER
--------------	---	-----------------------

증상	피니셔 대량 적재 불가 소량 적재후 가득 참 메시지 발생
해결	WG8-5848 IC, PHOTO-INTERRUPTER 3개 교체

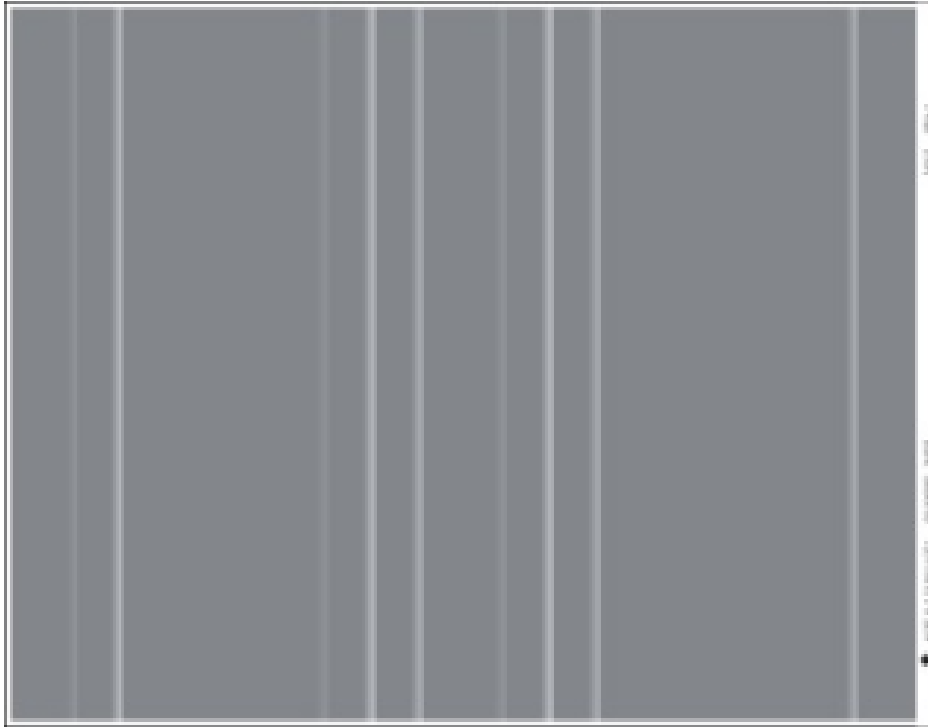
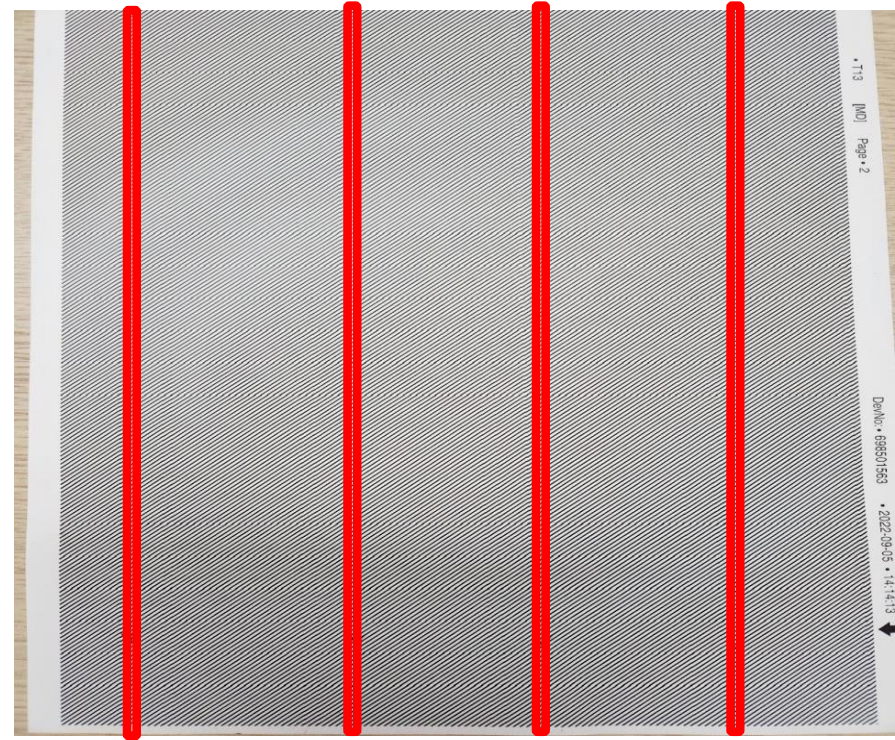
# DRUM 불규칙 백선 (축방향)

증상	현상 드라이브 유닛 불량 화상과 유사 불규칙적인 백선 발생
해결	현상 프레임 교체 테스트 동일 DRUM UNIT 교체

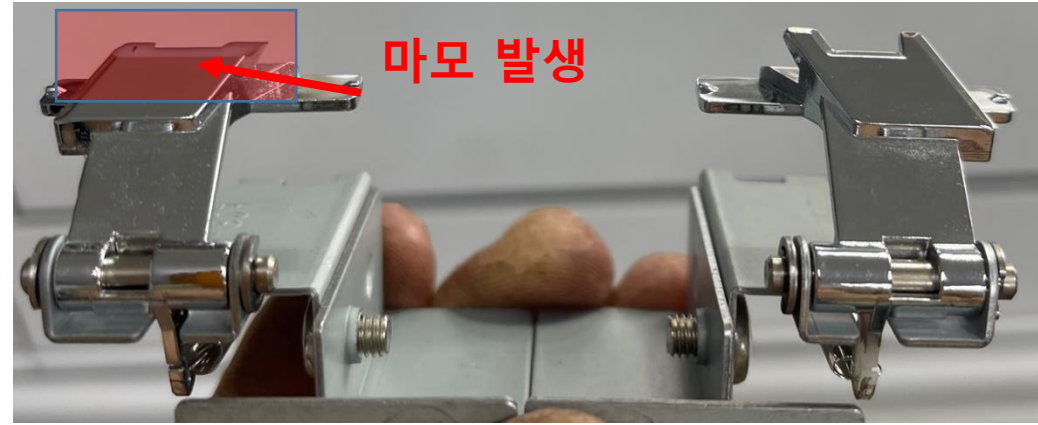
Stopper 위치 및 점검

증상	펀치 홀 사행 발생 및 정합 불량
해결	Stopper 마모에 의한 증상 발생 (Stopper 교체 FC0-3965, FC0-3966)

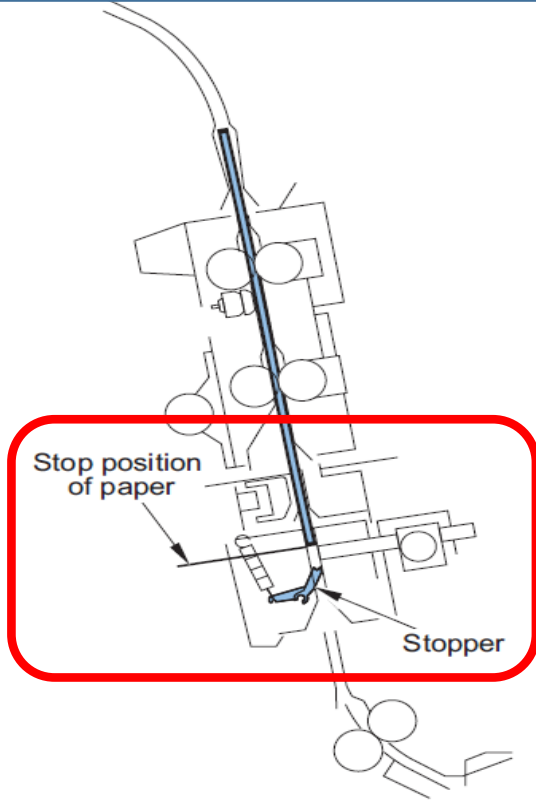
Stopper 위치 조정 포인트

증상	Stopper 교체 FC0-3965, FC0-3966 교체, 또는 신규 장착후 증상 발생
해결	Stopper 좌,우 높이 조정 및 출력물 위치 확인하여 조정 하여 수정

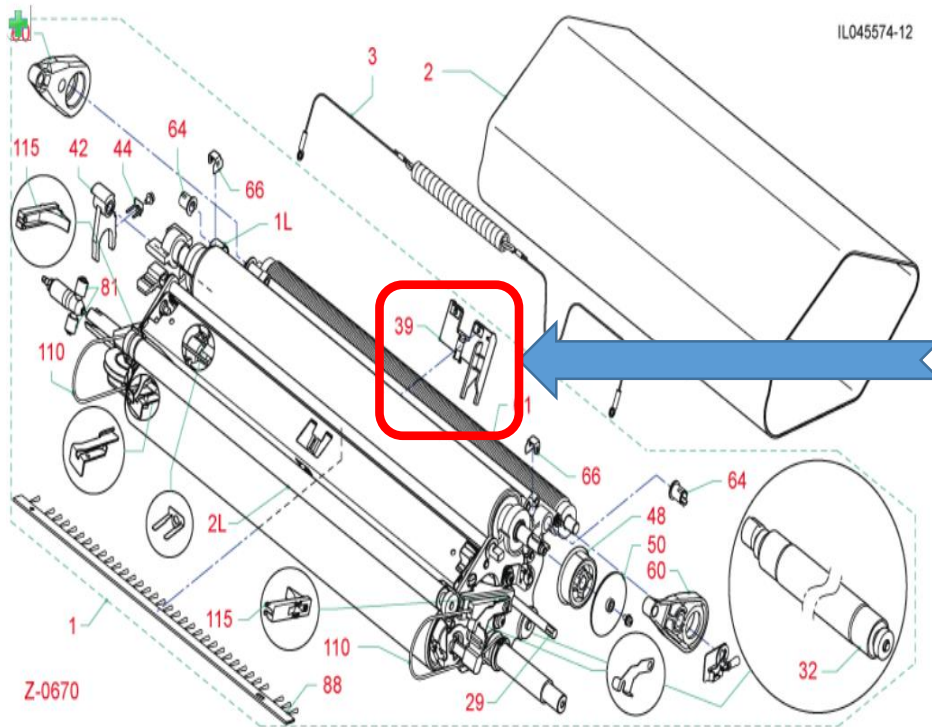
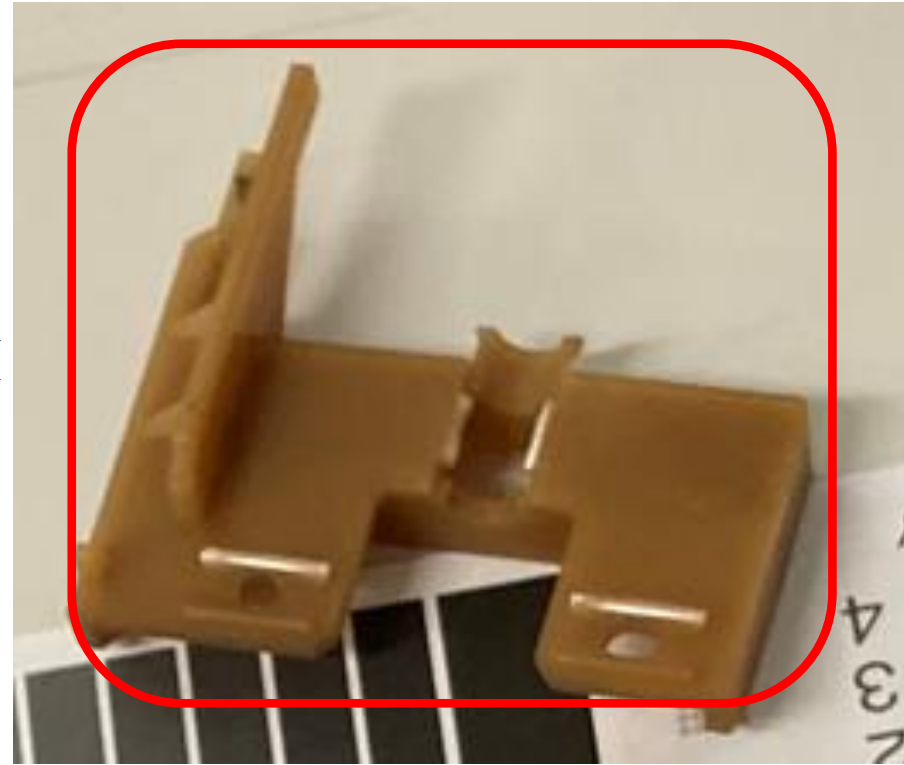
# TTF Belt 치우침 으로 변형

## BLOCK 위치 및 점검

증상	TTF BELT 한쪽으로 치우침
해결	BLOCK 확인후 교체 <b>1060080694</b>

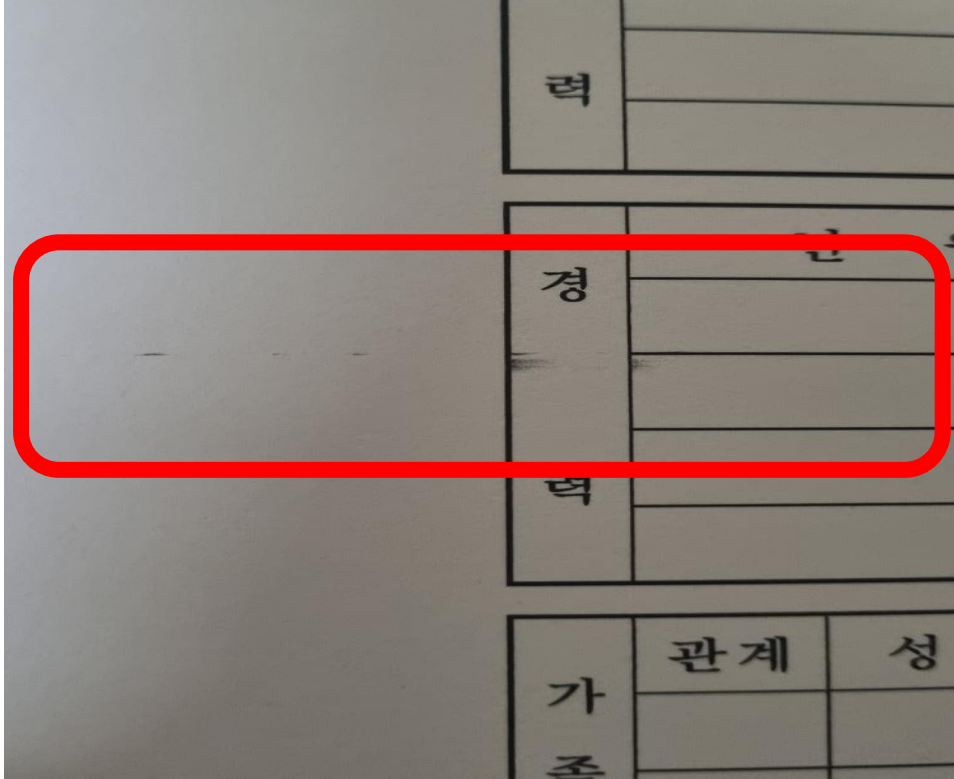
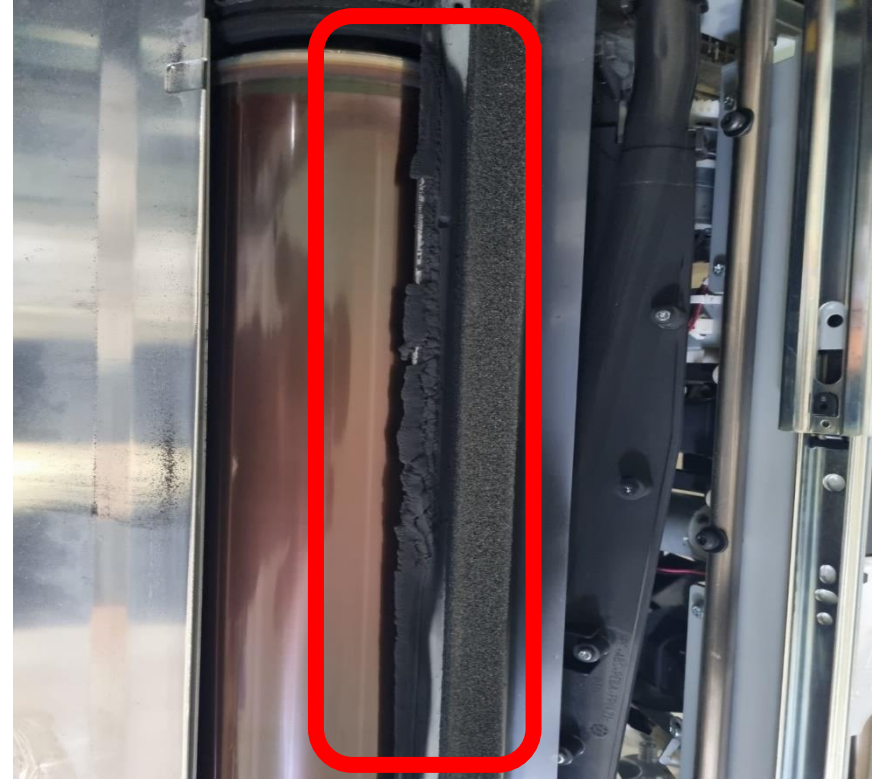
# 화상 불량 (쓰림 현상)

토너 누적으로 인한 화상 불량

증상	비산 토너 누적으로 인한 드럼 표면 간섭 발생
해결	클리닝후 해결 (정기적인 점검 포인트)

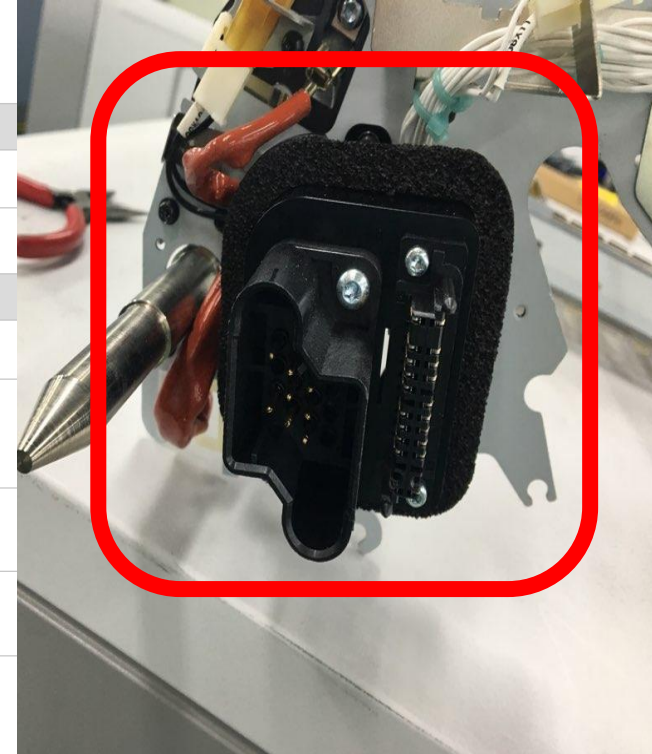
## 6576 safety circuit power failure

Error code 6576 WPR safety circuit power failure

증상	비글파워, 비글코어, 파워유닛, 프리히터 교체 에러 동일 프리히터 케이블 제거 후 기동에도 에러 변하지 않음 (정상 기기 E6522)
해결	프레임 교체 1070041791 SUPPORT FRAME ASSY (PACKED)

Action	Info
2	Disconnect 06X3 from the Preheater plate, WPR.	• <a href="#">Pre Heater WPR, 0665</a>
3	If the error is no longer present when Preheater plate, WPR is disconnected: <ul style="list-style-type: none"> <li>• Check wiring harness and connections between the Preheater plate, WPR and the PBA beagle power (22PBA02) and repair if necessary.</li> </ul>	• <a href="#">Wiring Diagram</a>
4	If the problem persists when Preheater plate, WPR is disconnected: <ul style="list-style-type: none"> <li>• Disconnect 2205X13 from the Power supply unit.</li> </ul>	• <a href="#">Wiring Diagram</a>
5	If the problem persists: <ul style="list-style-type: none"> <li>• Replace the PBA beagle power (22PBA02).</li> </ul>	• <a href="#">Remove the PBA beagle power (22PBA02)</a>
6	If the error is no longer present: <ul style="list-style-type: none"> <li>• Check wiring harness and connections between the PBA beagle power (22PBA02) and the Power supply unit and repair if necessary.</li> </ul>	• <a href="#">Wiring Diagram</a>

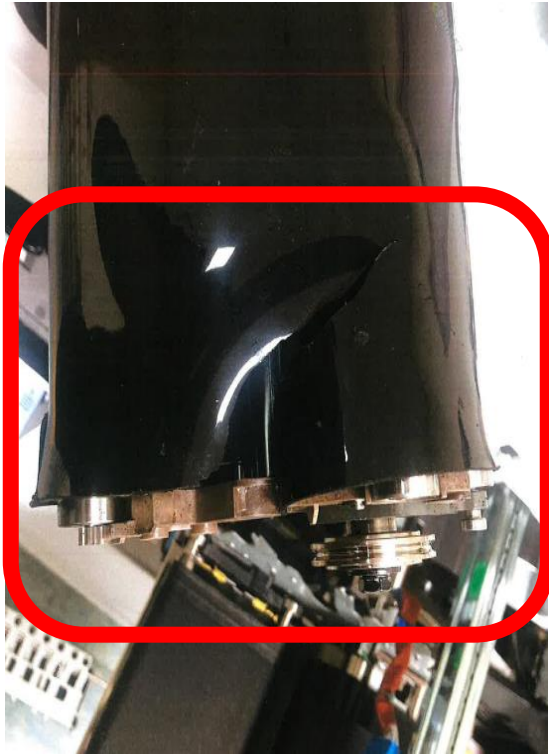
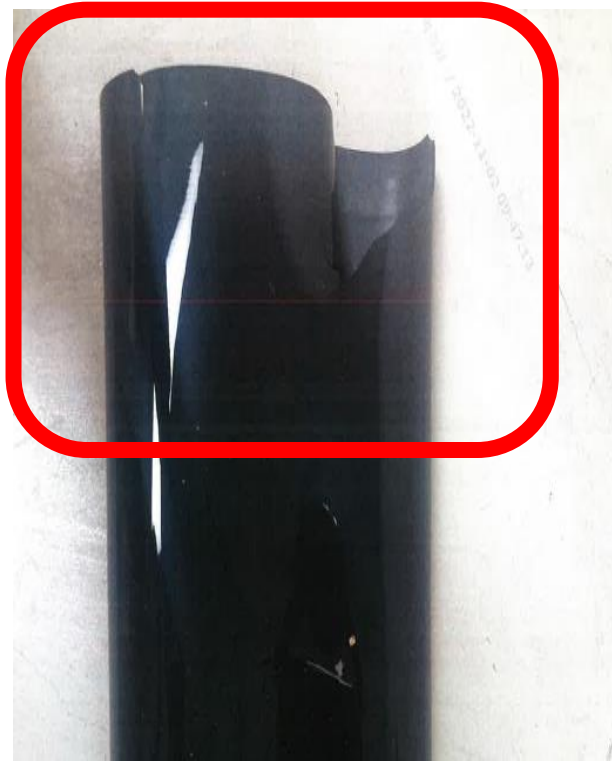
VP140's 초기설치 필수 확인 사항

증상	초기 워밍업 후 출력시 소음 동반 벨트 파손 발생 (ERR 6537, 6534)
해결	초기 설치시 Counter Pressure Unit 정상장착 확인후 전원 투입

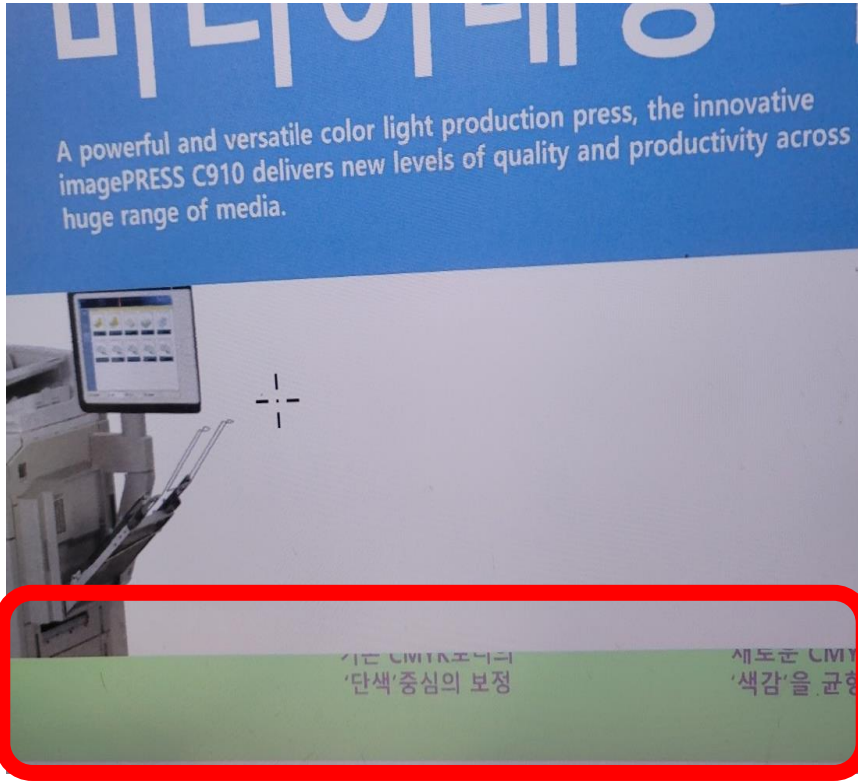
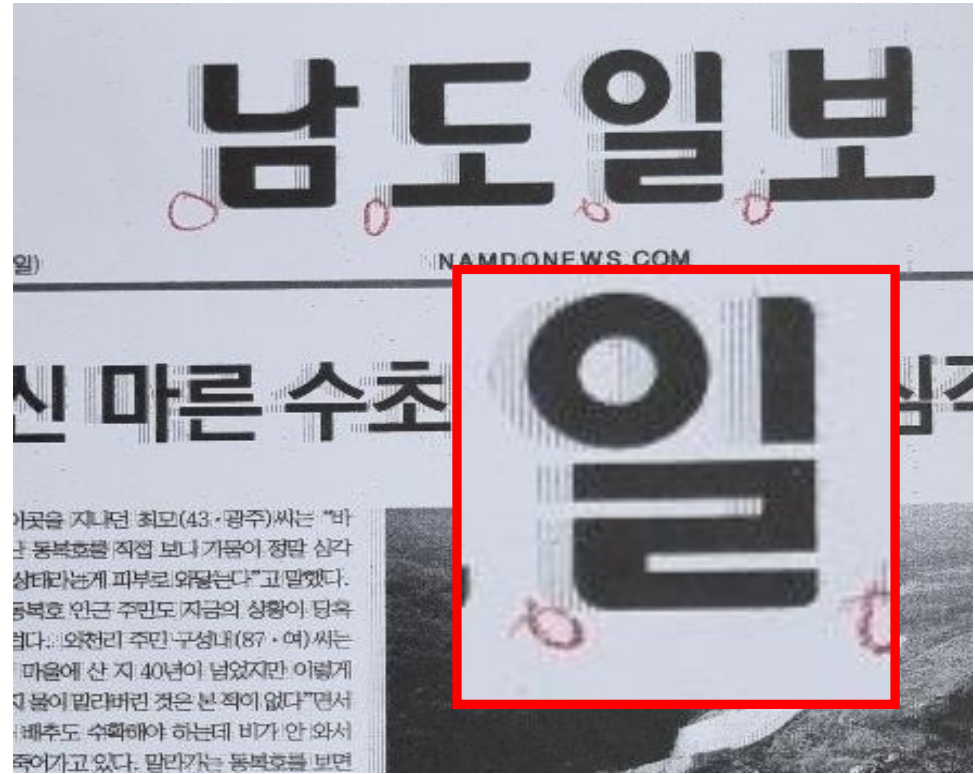
# 복사/스캔 화상 불량

평판 및 DADF 화상 불량

증상	스캔 사용시 뒷장 과 합성된 이미지 발생 / 복사 사용시 음영발생
해결	PBAP, BEAGLE_CORE 교체 1070066229 SODIMM, DDR2 128 X64 1GB 교체 후 정상 작동

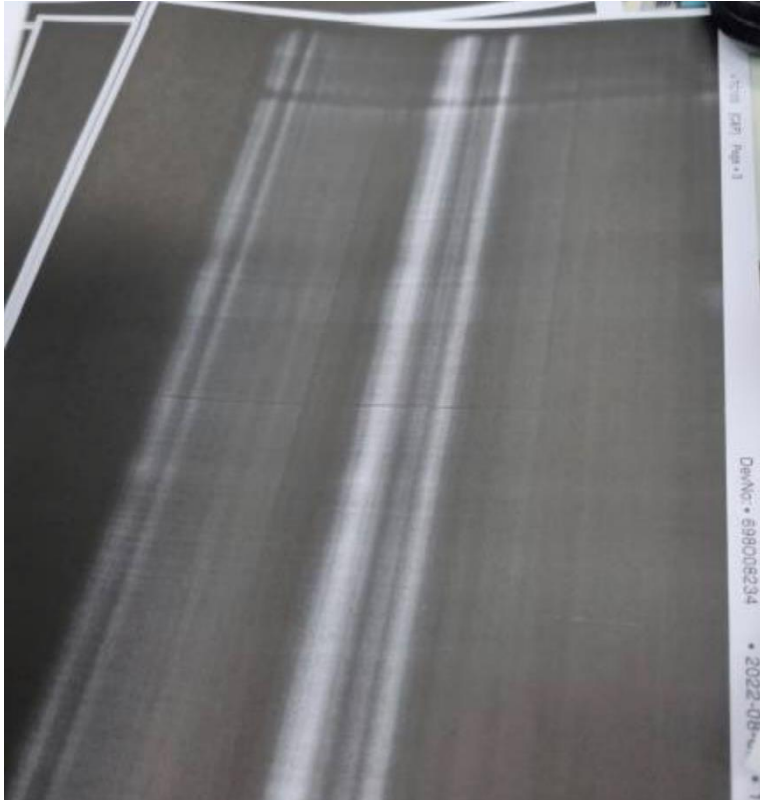
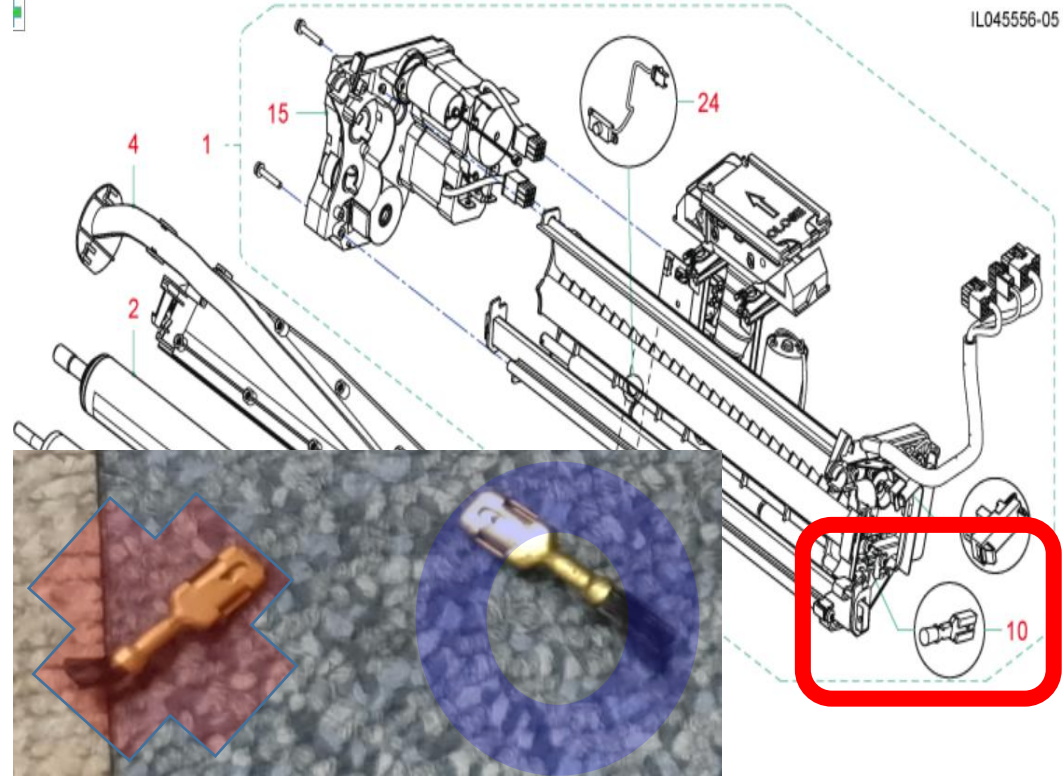
# 화상 축 방향 불량 발생

증상	축 방향 화상 불량 발생 (제전 카본 브러쉬 마모)
해결	1060091477 BRUSH CARBON-ANTISTATIC 6MM 교체

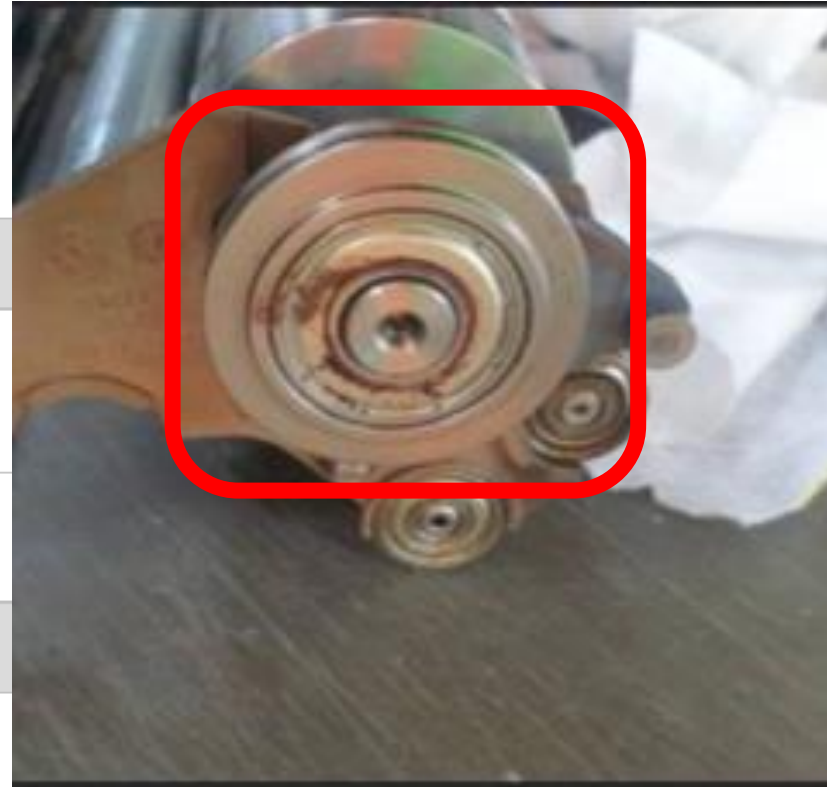
# ERR 6527 발생

증상	워밍업 중 COUNTER PRESSURE UNIT 가압 동작시 ERR 6527 발생
해결	부품 상태 확인 하여 1070094835 PRESSURE-ROLLER-ASSY 또는 1070095221 COUNTER PRESSURE UNIT ASSY 교체

Action	Info
1 Replace the Cleaner unit, WPR.	<ul style="list-style-type: none"><li>Remove the Cleaner unit, WPR</li><li>TTF-Cleaner Unit Frameparts Base, 0635</li></ul>

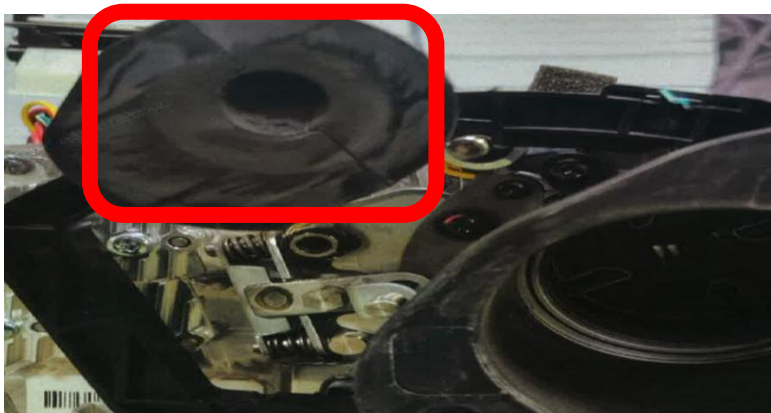
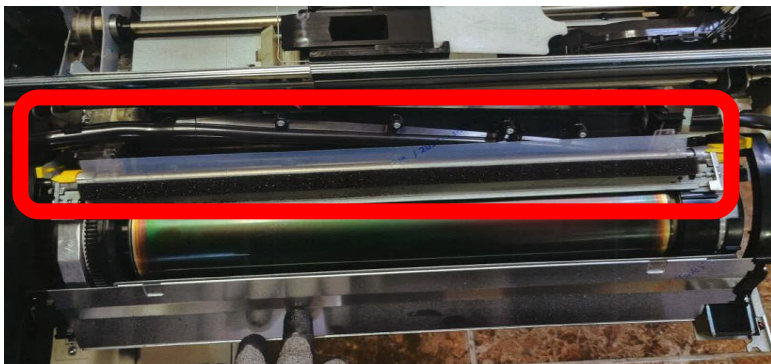
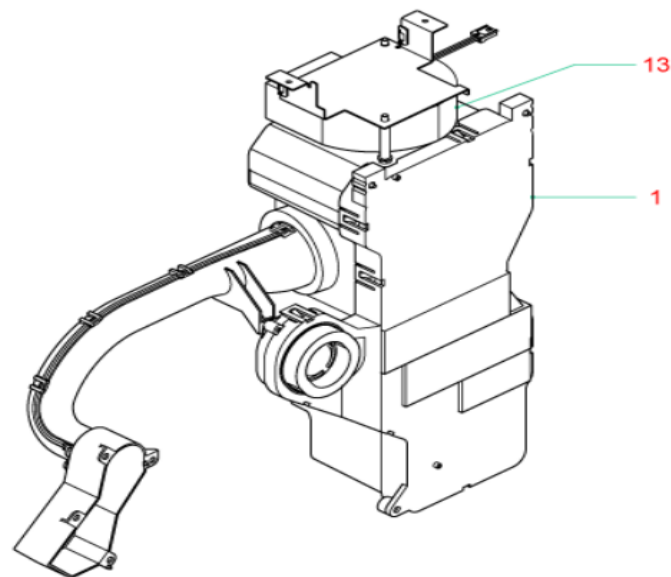
## 토너 포집 불량

Part no	Qty	Description
1060099314	1	BOX FILTER ASSY (PACKED)
1060099635	1	FAN,ASSY (PACKED)

증상	토너 포집 불량으로 드럼 상단 부 토너 비산 및 화상 불량 원인
해결	1060099314 필터 박스 내부 클리닝 진행 (내부 필터 막힘 현상으로 포집 불가 원인)

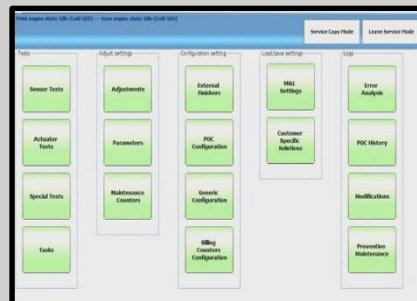
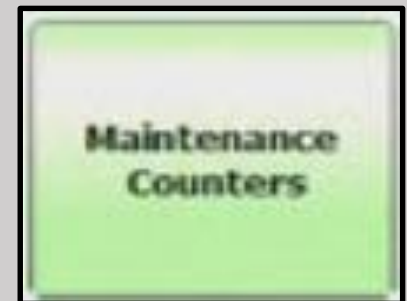
- 서비스모드 -
- Maintenance Counters
- /printer/Warm Process
- /Number of images with preheater belt.
