# VP140 해결 사례 공유

Ver 23.11 SF

PS지원담당

23. 11. 05

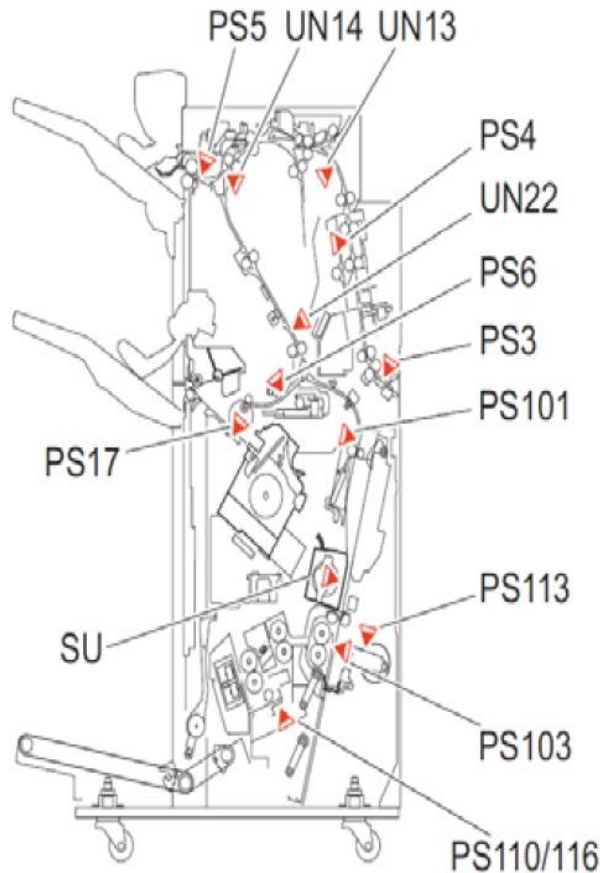
### Staple Finisher-W1/Booklet Finisher-W1

Océ	Jam Code	Type	Sensor Name / Description	Sensor ID
1870200	1002	DELAY	Inlet Sensor	PS3
1870201	1004	DELAY	Shift Unit Trailing Edge Sensor	PS4
1870202	1006	DELAY	Buffer Path 1 Sensor PCB	UN13
1870203	1008	DELAY	Buffer Path 2 Sensor PCB	UN14
1870204	100A	DELAY	Upper Delivery Sensor	PS5
1870205	100C	DELAY	Lower Path Sensor PCB	UN22
1870206	100E	DELAY	Lower Delivery Sensor	PS6
1870207	1042	DELAY	Saddle Inlet Sensor	PS101
1870208	1046	DELAY	Saddle Vertical Path Sensor	PS103
1870209	104A	DELAY	Saddle Press Front Sensor	PS116
1870210	1054	DELAY	Saddle Press HP Sensor	PS113
1870211	1103	STNRY	Inlet Sensor	PS3
1870212	1105	STNRY	Shift Unit Trailing Edge Sensor	PS4
1870213	1107	STNRY	Buffer Path 1 Sensor PCB	UN13
1870214	1109	STNRY	Buffer Path 2 Sensor PCB	UN14
1870215	110B	STNRY	Upper Delivery Sensor	PS5
1870216	110D	STNRY	Lower Path Sensor PCB	UN22
1870436	110F	STNRY	Lower Delivery Sensor	PS6
1870218	1143	STNRY	Saddle Inlet Sensor	PS101

1870219	1147	STNRY	Saddle Vertical Path Sensor	PS103
1870220	114B	STNRY	Saddle Press Front Sensor	PS116
1870221	1155	STNRY	Saddle Press HP Sensor	PS113
1870222	1231	OTHER	-	-
1870223	1320	POWER ON	-	-
1870224	1422	DOOR OP	-	-
1870225	1524	STAPLE	-	-
1870226	1550	SDL STP	-	-
1870227	1721	OTHER	-	-
1870228	1C01	OTHER	-	-
1870229	1F03	OTHER	-	-
1870230	1F25	OTHER	-	-
1870231	1F30	OTHER	-	-
1870232	1F31	OTHER	-	-
1870233	1F52	OTHER	Saddle Press HP Sensor	PS110

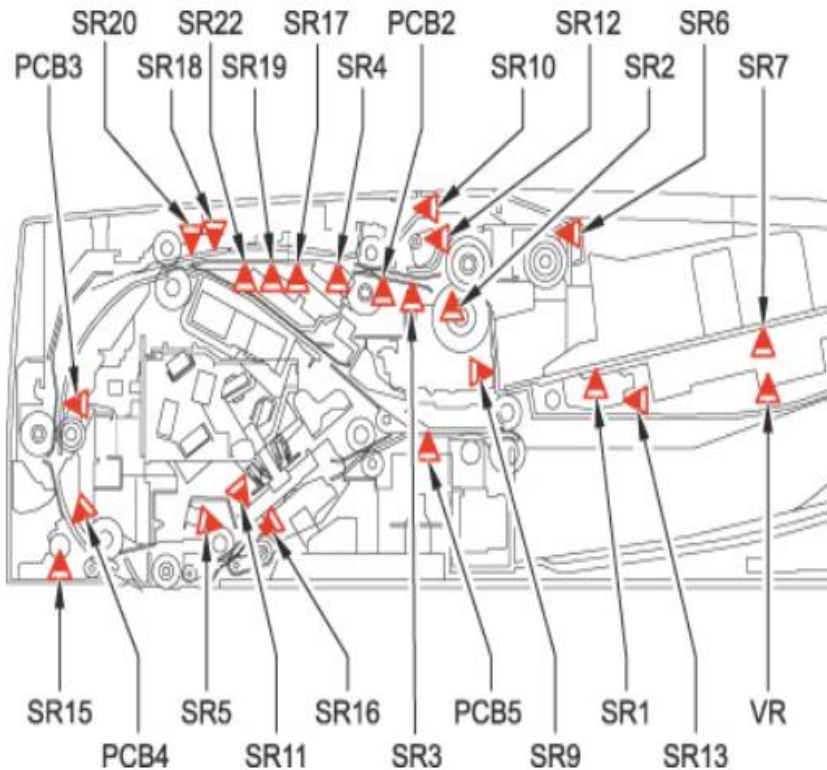
## 센서 위치 기능

Code	Name	Jam detection			
		Delay	Stationary	Residue	Others
SR1	Original sensor	-	-	-	-
SR2	Post-separation sensor 1	-	-	-	Yes
SR3	Post-separation sensor 2	-	-	-	Yes
SR4	Delay sensor	Yes	Yes	Yes	-
SR5	Lead sensor 2	Yes	Yes	Yes	-
SR6	Paper surface sensor	-	-	-	-
SR7	AB/ Inch identification sensor	-	-	-	-
SR8	LTR-R/ LGL identification sensor	-	-	-	-
SR9	Tray open/closed sensor	-	-	-	-
SR10	Cover open/closed sensor	-	-	-	Yes
SR11	Glass shifting HP sensor	-	-	-	-
SR12	Pickup roller unit lifter HP sensor	-	-	-	Yes
SR13	Tray HP sensor	-	-	-	-
SR15	Disengaging HP sensor 1	-	-	-	Yes
SR16	Disengaging HP sensor 2	-	-	-	Yes
SR17	Original size sensor 1	-	-	-	-
SR18	Original size sensor 2	-	-	-	-
SR19	Original size sensor 3	-	-	-	-
SR20	Original size sensor 4	-	-	-	-
SR22	Leading edge position sensor	-	-	Yes	-
PCB2	Post-separation sensor 3	Yes	Yes	Yes	Yes
PCB3	Registration sensor	Yes	Yes	Yes	-
PCB4	Lead sensor 1	Yes	Yes	Yes	-

PCB5	Delivery sensor	Yes	Yes	Yes	-
VR	Original width volume	-	-	-	-

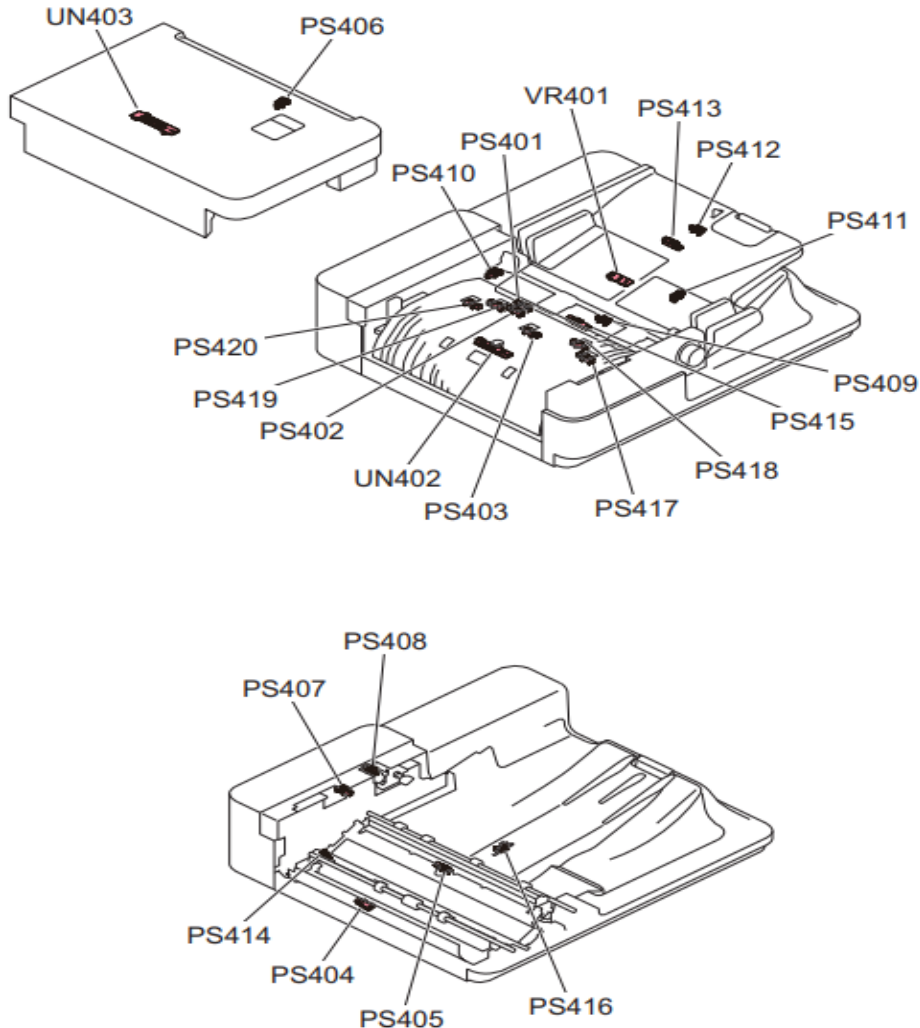
## 센서 위치 기능

Symbol	Name	Detection description
VR401	Original Width Detection Resistance	Original width length detection
PS401	Pre-separation Sensor	The position of the leading edge of the original immediately before pickup
PS402	Post-separation Sensor	The position of the leading edge of the original immediately after pickup
PS403	Pullout Sensor	The position of the leading edge of the original after pulling out to pickup
PS404	Read Sensor	Image reading start/end timing
PS405	Pre-delivery Sensor	The position of the trailing edge of the original before delivery
PS406	Tray Paper Surface Sensor	Presence of original paper surface on the original pickup tray
PS407	Cover Open/Closed Sensor	Opening/closing of the Feeder Cover
PS408	Pickup Roller Lifting HP Sensor	Home position of the Pickup Roller that rises and lowers
PS409	ADF Sleep Exit Sensor	Presence of original on the Document Pickup Tray
PS410	Tray Lifting HP Sensor	Home position of the tray that rises and lowers

PS411	AB/Inch Identification Sensor	Distinguish between A4R and LTRR, between A5R and STMTR
PS412	LGL Identification Sensor	Distinguish between LTR-R and LGL
PS413	Large Size/ Small Size Sensor	Identify the original warping and bending
PS414	Paper Back Reading Glass HP Sensor	Reading Glass position
PS415	Original Sensor	Presence of original on the Document Pickup Tray
PS416	Delivery Stack Detection Sensor	Capacity of Delivery Tray
PS417	Skew Detection Sensor (Large, Front)	Detect skewing of original by the time difference of detection timing
PS418	Skew Detection Sensor (Small, Front)	
PS419	Skew Detection Sensor (Small, Rear)	
PS420	Skew Detection Sensor (Large, Rear)	
UN402	Double Feed Detection Sensor PCB (Transmission)	Double feed detection (transmission)
UN403	Double Feed Detection Sensor PCB (Reception)	Double feed detection (reception)

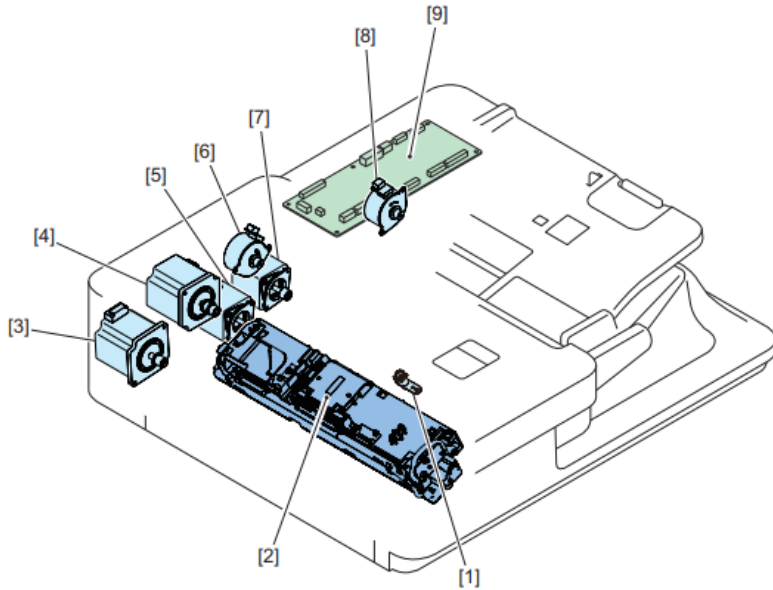
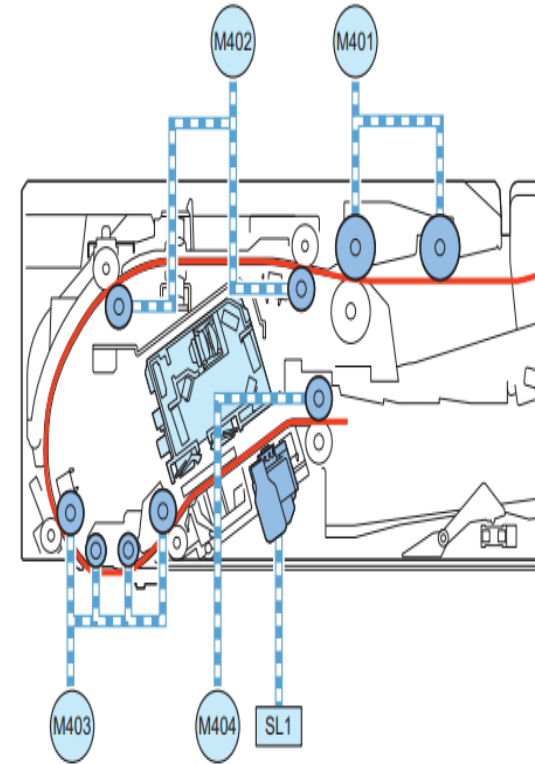
Key No.	Name	Symbol
[1]	Stamp Solenoid	SL401
[2]	Scanner Unit	-
[3]	Read Motor	M403
[4]	ADF Pull-out Motor	M402
[5]	ADF Delivery Motor	M404
[6]	Pickup Roller Lifting Motor	M405
[7]	ADF Pickup Motor	M401
[8]	Tray Lifting Motor	M406
[9]	ADF Driver PCB	UN_401

Symbol	Name	Role
M401	Pickup Motor	Drive of Pickup Roller
M402	Pull-out Motor	Drive of Pull-out Roller
M403	Read Motor	Drive of Read Roller
M404	Delivery Motor	Drive of Delivery Motor, Movement of Glass
M405	Pickup Roller Lifting Motor	Drive of Pickup Roller Lifting Roller
M406	Tray Lifting Motor	Drive of Tray Lifting
SL401	Stamp Solenoid	Stamp drive

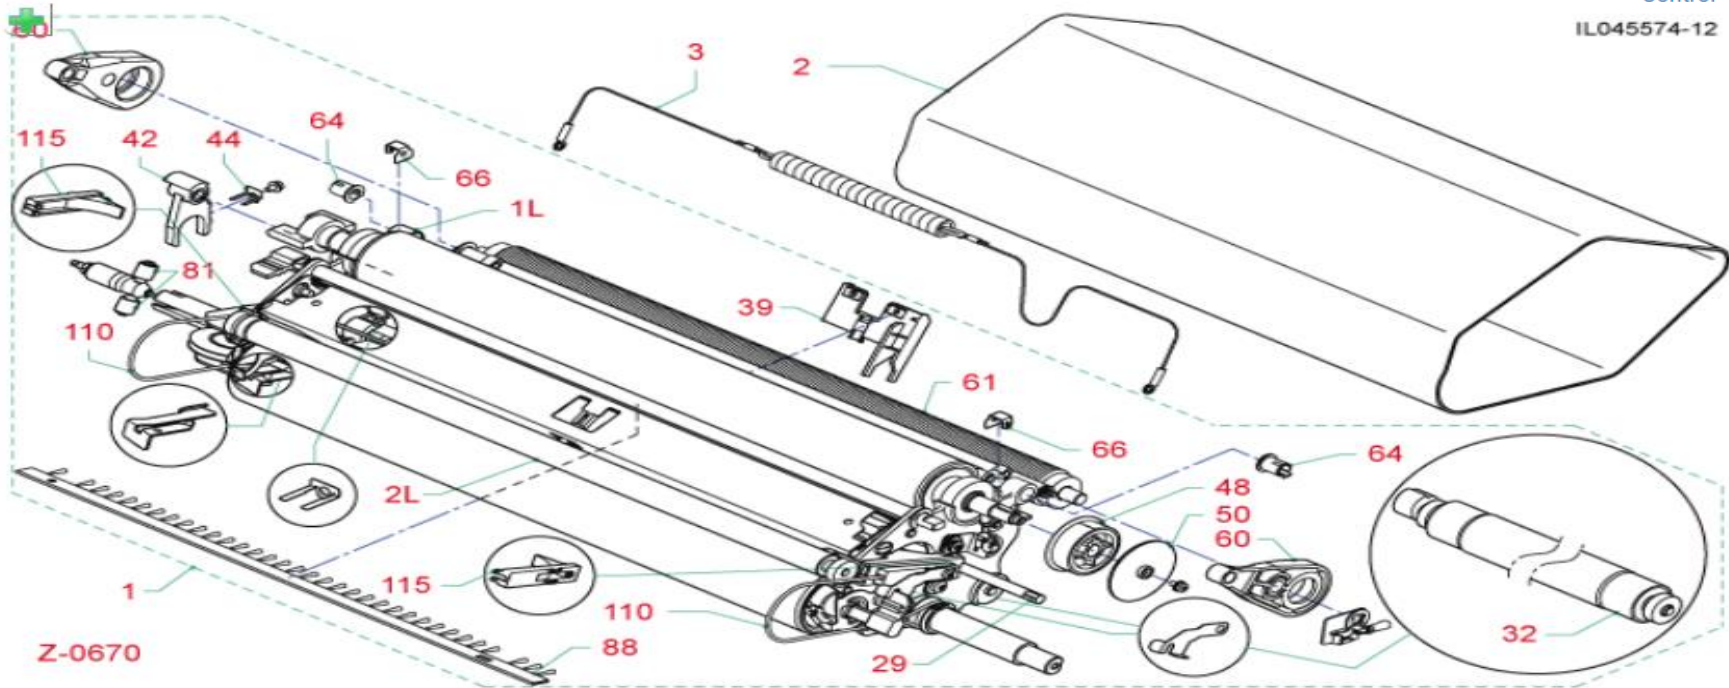
IL045574-12

Index	Part no	Qty	Description	Note:
1	1070075402	1	TTF UNIT ASSY (PACKED)	
1L	1060127357	1	ROLLER-DRIVE-ASSY	If waxm
2	1060075549	1	PCK,FUSER BELT	
3	1070012863	1	TENSION-SPRING	
32	1070089066	1	TRANSFER ROLLER CPL	O

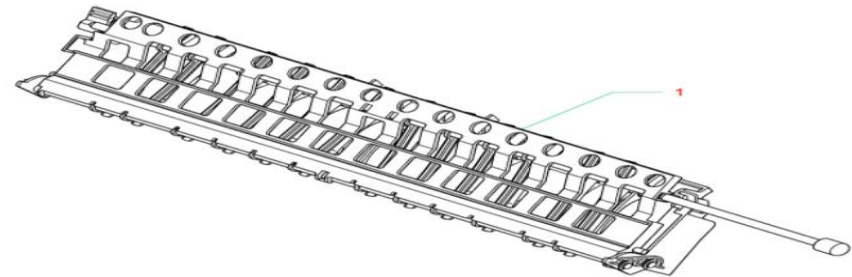
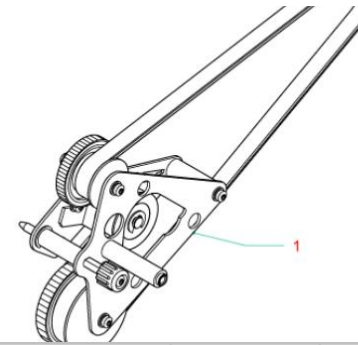
Z-0685

Part no	Qty	Description
1070033545	1	PAPER OUTPUT UNIT ASSY (PACKED)

Part no	Qty	Description
1070006980	1	DRIVE FRONT,WPR (PACKED)

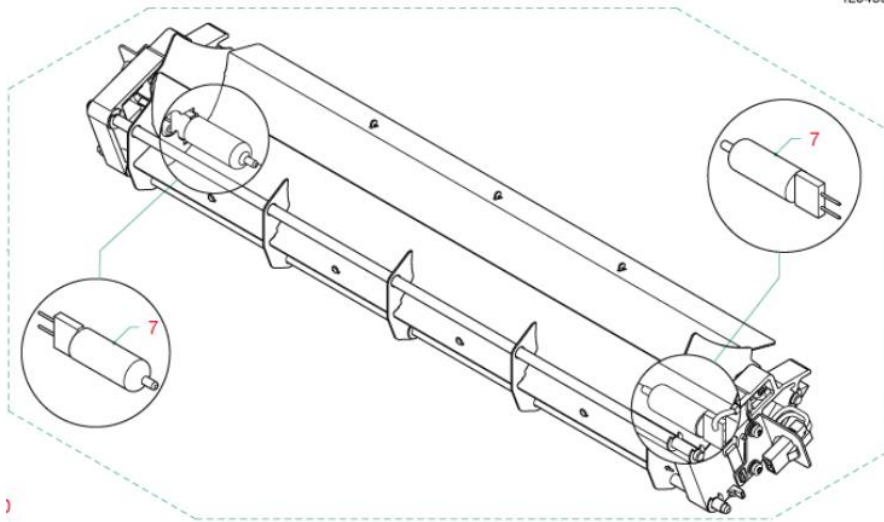
Heat on Demand Unit

Index	Part no	Qty	Description
1	1070026332	1	HEAT ON DEMAND UNIT ASSY (PACKED)
7	1070089504	1	HALOGEN LAMP AC 120V 150W - COMPLETE

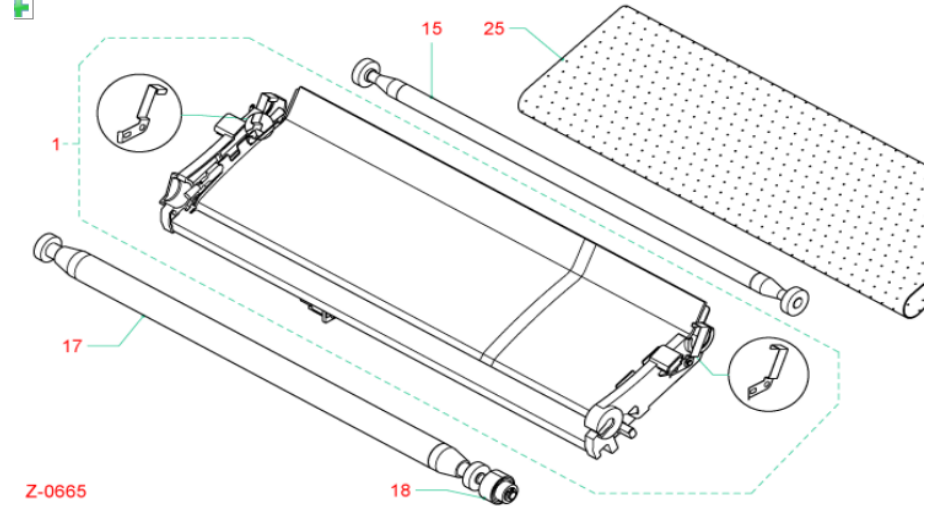
Pre Heater

Index	Part no	Qty	Description
1	1070107908	1	PRE HEATER,WPR (PACKED)
15	1070038256	1	ROLLER-12,5MM (PACKED)
17	1070038253	1	ROLLER-19,2MM-CPL (PACKED)
18	1060082259	1	GEAR-19X1-ASSY
25	1060075551	1	PCK,PHB67

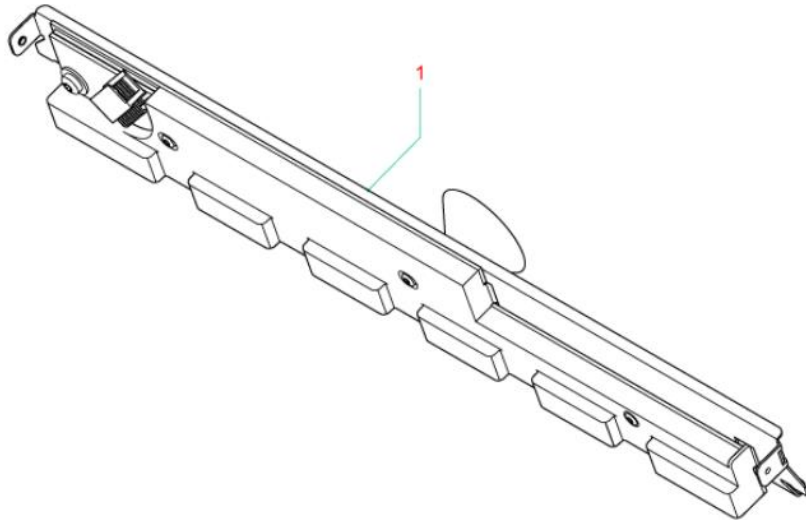
Sensor Box

Index	Part no	Qty	Description
1	1060127352	1	SENSOR BOX

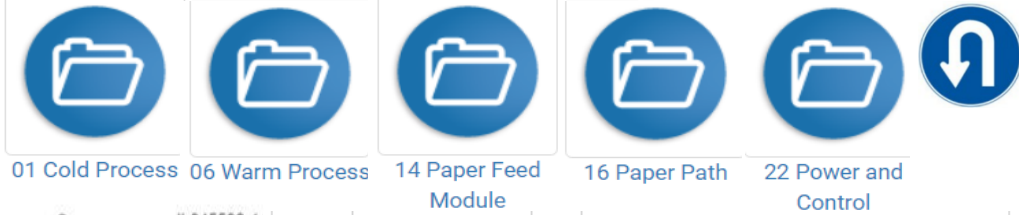
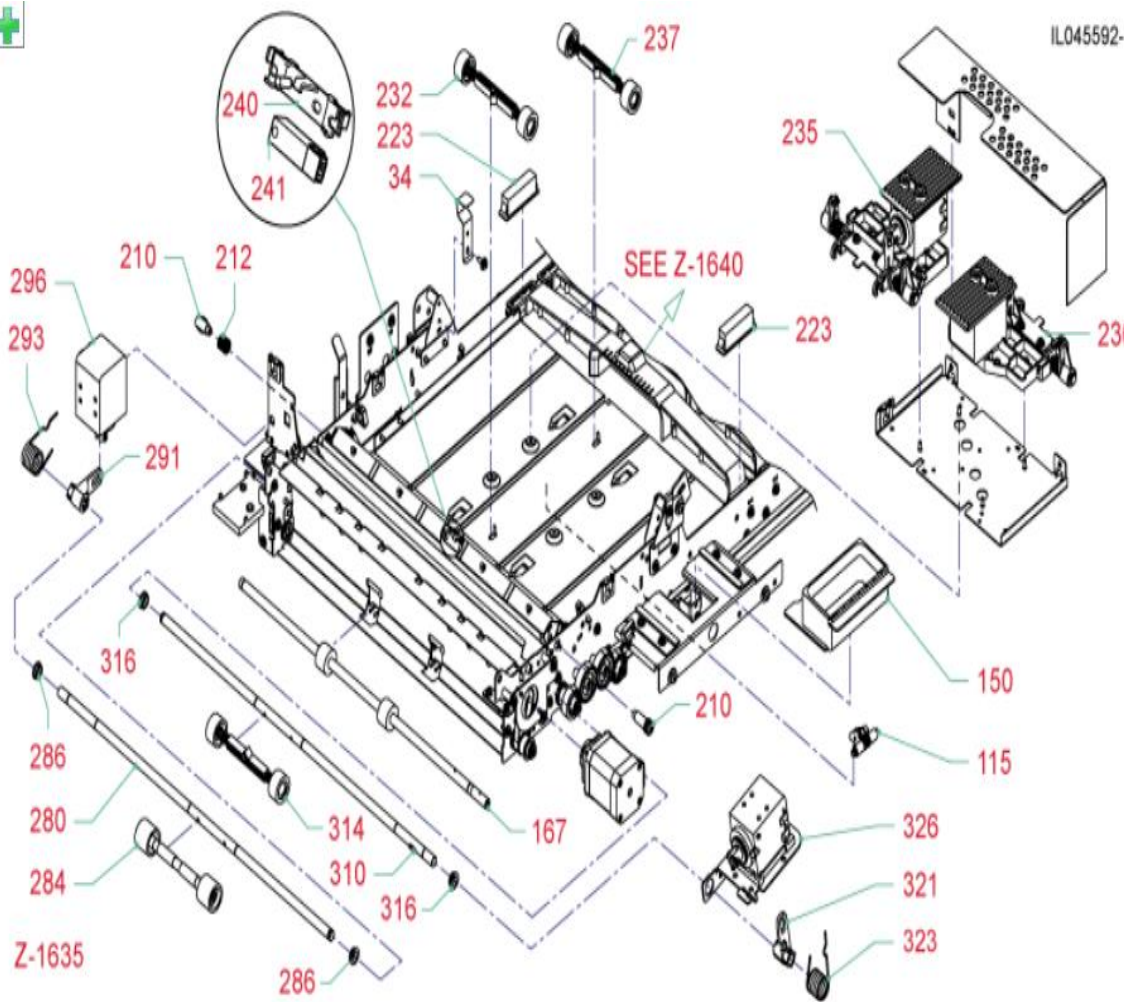
## Horizontal Transport PAP (Left)

Index	Part no	Qty	Description
34	1060099612	1	SPRING-LEAF (PACKED)
115	1070041413	1	LEVER CPL.
150	1060086626	1	GRIP
167	1060114013	1	ROLLER-ASSY
210	1060086777	2	HINGE-FRONT
212	3861106	1	SPRING,CPRSN-0,8 X10X 20
223	1020200	2	CATCH,MAGNETIC
230	1070103478	1	LIFT-MECHANISM (PACKED)
232	1070113661	1	ROLLER,PRESSURE STEER (PACKED)
235	1070103478	1	LIFT-MECHANISM (PACKED)
237	1070113661	1	ROLLER,PRESSURE STEER (PACKED)
240	1060128430	1	BLOCK,SENSOR (PACKED)
241	1060026381	1	ENCODER, OPTICAL REFLECTIVE PAN
280	1060086558	1	SHAFT-LIFT
284	1060130263	1	ROLLER-PRESSURE (PACKED)
286	1060086559	2	BUSH-LIFTSHAFT
291	1070042493	1	LEVER CPL.
296	1060099617	1	SOLENOID, ASSY (PACKED)
310	1060086558	1	SHAFT-LIFT
314	1070113661	1	ROLLER,PRESSURE STEER (PACKED)
316	1060086559	2	BUSH-LIFTSHAFT
321	1070042493	1	LEVER CPL.
326	1060099617	1	SOLENOID, ASSY (PACKED) (16Y4)

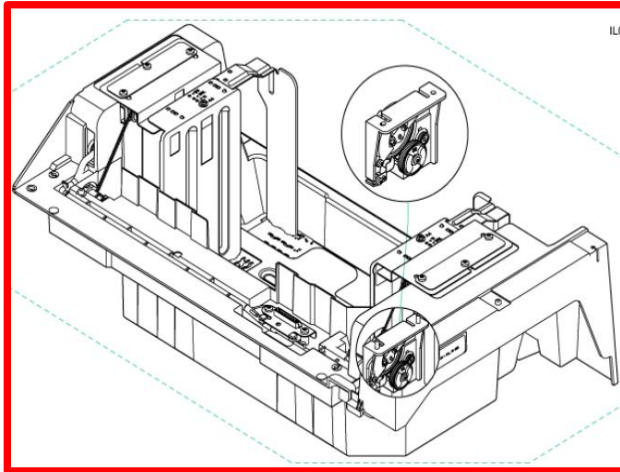
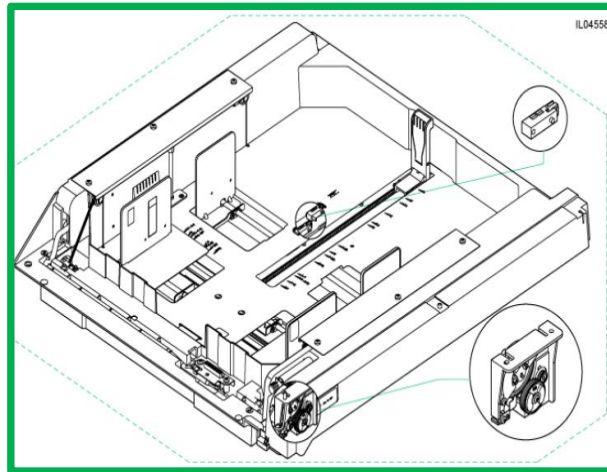
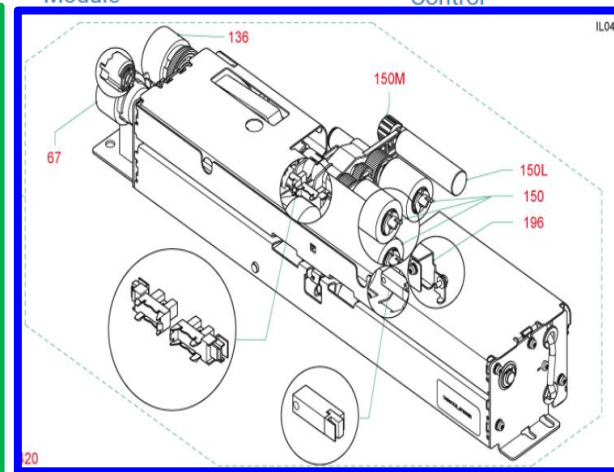
## Paper Feed Module

Index	Part no	Qty	Description	Note:
0	1070037091	1	<b>BULK PAPERTRAY ASSY</b>	
0	1070037089	1	<b>MULTIFORMAT PAPERTRAY</b>	
0	1070028618	1	<b>SEPARATION UNIT ASSY</b>	
67	7024023	1	CLUTCH,EC30-LL-CW-8-24	
136	7024023	1	CLUTCH,EC30-LL-CW-8-24	
150	1070114017	1	SEPARATION KIT	
150L	1060099641	1	WEIGHT FEEDROLLER	
150M	1070026985	1	KNOB (PACKED)	
196	1060124245	1	BRACKET (PACKED)

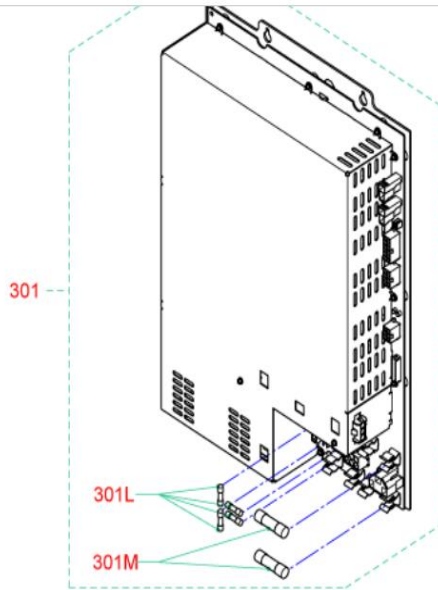
## Power Supply

Index	Part no	Qty	Description
301	1060130792	1	POWER SUPPLY
301L	1302028	4	FUSE,CER-5A S 5X20
301M	1301935	2	FUSE, 20A 10.3X38

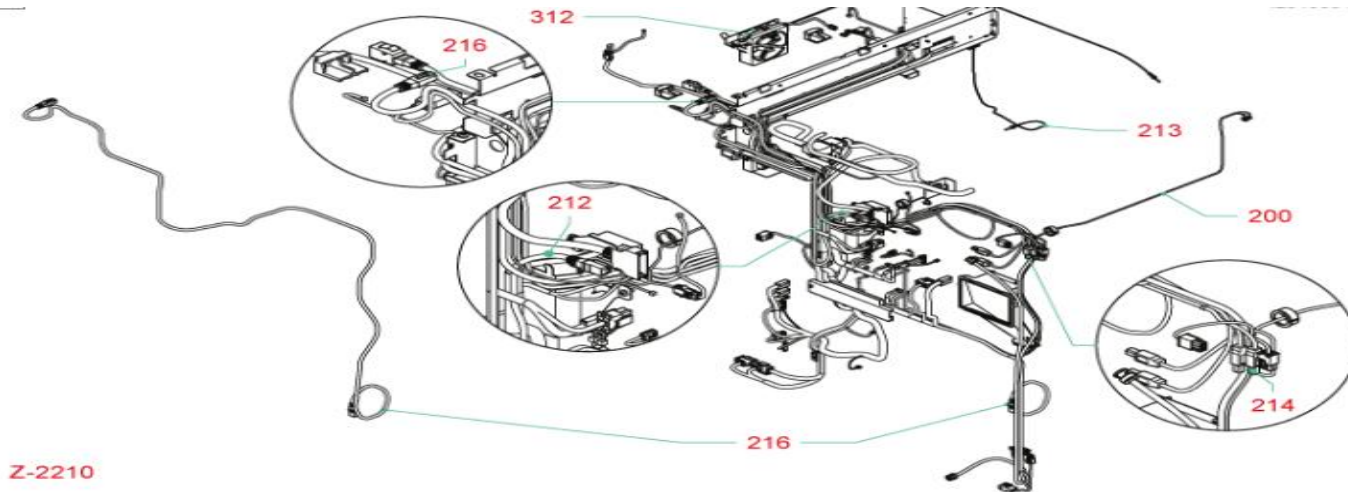
Electro Frameparts Frame Upper

Index	Part no	Qty	Description	Note:
200	1070063149	1	HARNESS,22W01	
212	1060028851	1	CABLE ASS DATA, RJ45 RJ45 Ivory 1M	
213	1060115776	1	OPTICAL-FIBER (PACKED)	
214	1060029172	1	CABLE ASS DATA, USB-A USB-B BLACK 1 .8M	USB cable from Beagle to Controller
216	1060028853	1	CABLE ASS DATA, RJ45 RJ45 IVORY 2M	
312	1060099624	1	FAN-ASSY (PACKED)

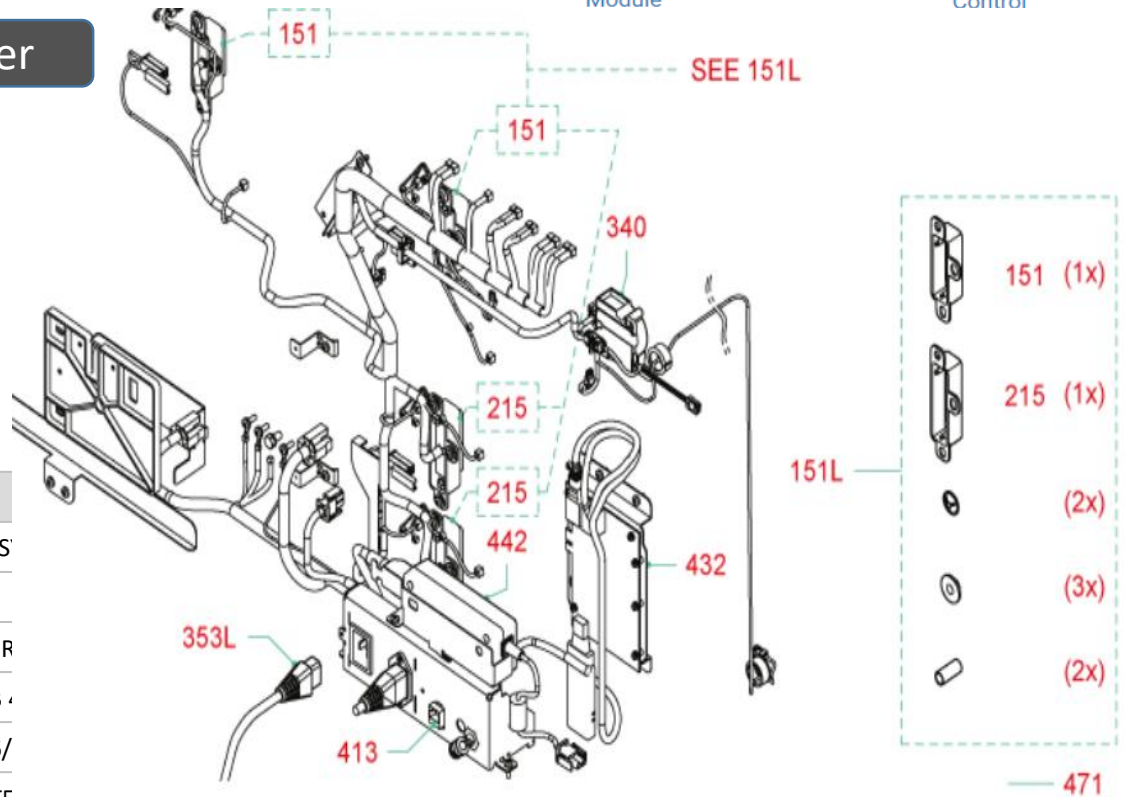
## Electro Frameparts Frame Lower

Index	Part no	Qty	Description
151L	1070036787	1	DRAWER CONNECTOR, ASSY
340	1070092014	1	FAN-ASSY (PACKED)
353L	1060059057	1	CABLE ASS MAINS, C19 EUR
353L	1060059080	1	CABLE ASS MAINS, C19 GB
353L	1070001250	1	CABLE ASS MAINS, C19 N6/
413	1070046401	1	ADDIT, COUPLER RJ45 CAT5

432	1070106814	1	PBAP,NETWORK_INTERF_PROXY(SERV)(PACKED)	- From serial number 698002501 up to and including 6985044
432	1070096039	1	PBAP,PSM	- From serial number 698504489
442	1070034102	1	POWER SUPPLY, 5V 25VA (PACKED)	- From serial number 698002501
471	1070108847	1	HARNESS,22W50

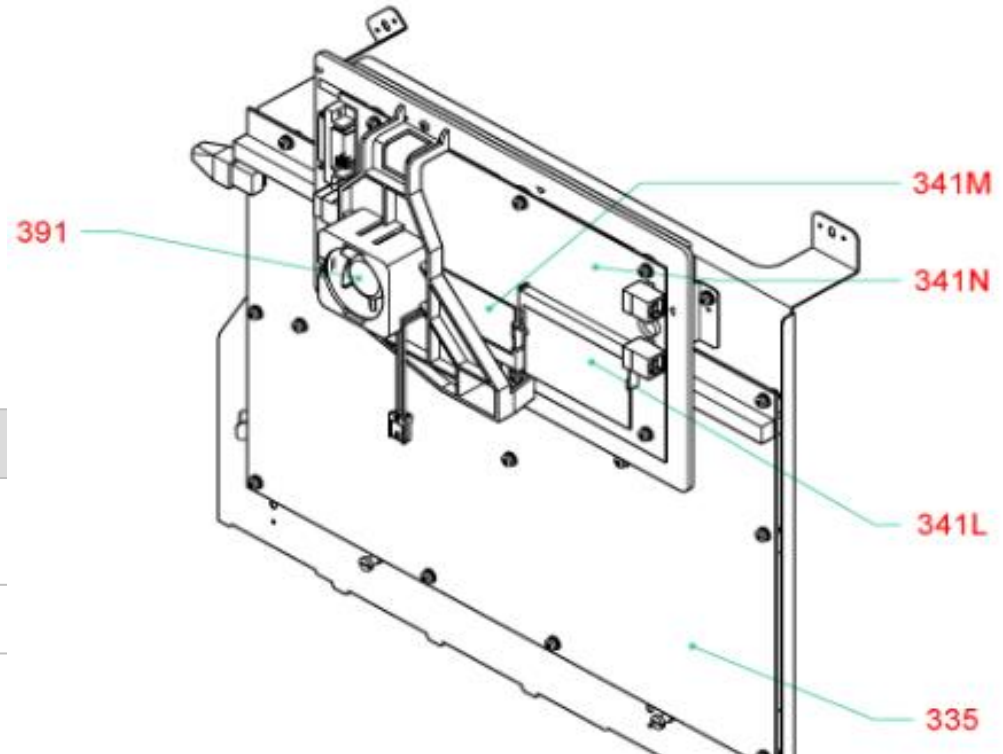
Beagle Assy Frame Upper

Index	Part no	Qty	Description	
335	1070064474	1	PBAP,BEAGLE6_POWER_IO (PACKED)	
341L	1070065289	1	PBAP,STING V3.1 (PACKED)	
341M	1070066229	1	SODIMM,DDR2 128 X64 1GB (PACKED)	
341N	1070064480	1	PBAP,BEAGLE5_CORE (PACKED)	Up to serialnumber 698506999
341N	1070118363	1	PBAP,BEAGLE_CORE_SD5 (PACKED)	From serialnumber 698507001
391	1070012261	1	FAN-ASSY (PACKED)

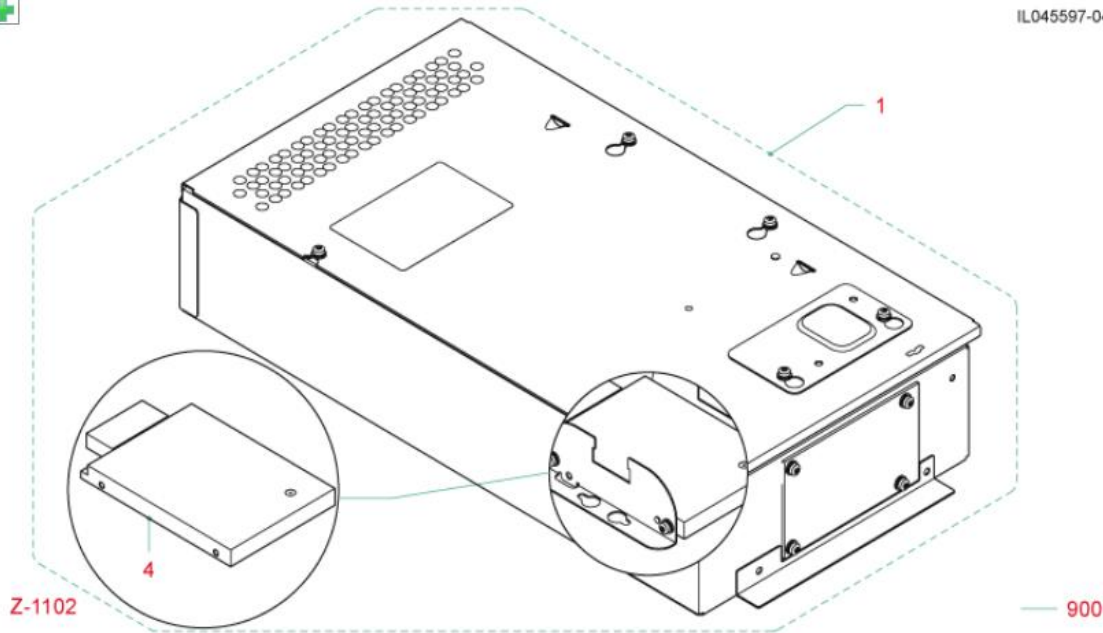
## Controller Box Assy

Index	Part no	Qty	Description	Note:
1	1070075205	1	CONTROLLER,ASSY T30	- Up to serial number 698505126 - Up to serial number 698002501 use controller together with part no.1070012128 HARNESS,22W25 TM2-CONNECTOR
1	1070120931	1	CONTROLLER_C30_V1	- From serial number 698505126
4	1070026265	1	HARD DISK SPARE PART

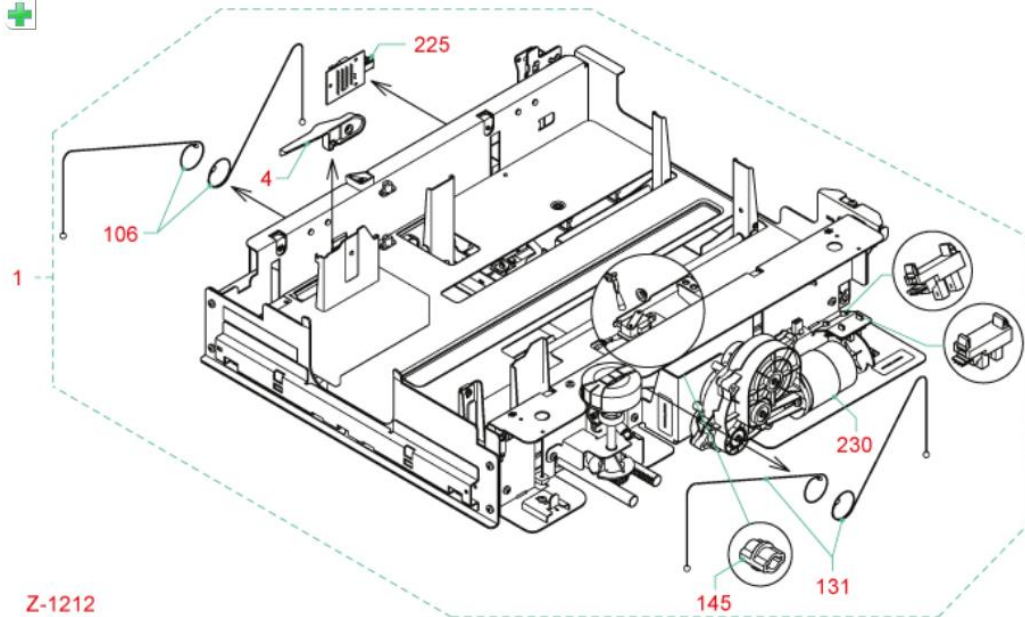
## Paper Tray Small

Index	Part no	Qty	Description	Note:
1	1070037090	1	PAPERTRAY,SMALL (PACKED)	
4	1060124364	1	LEVER (PACKED)	
106	1070126481	2	CABLE	
131	1070126481	2	CABLE	
145	1070091960	1	BUSH	
225	1060113792	1	PBA,TRAY_DISTRIBUTION (PACKED)	
230	1070012567	1	DRIVE UNIT PACKED

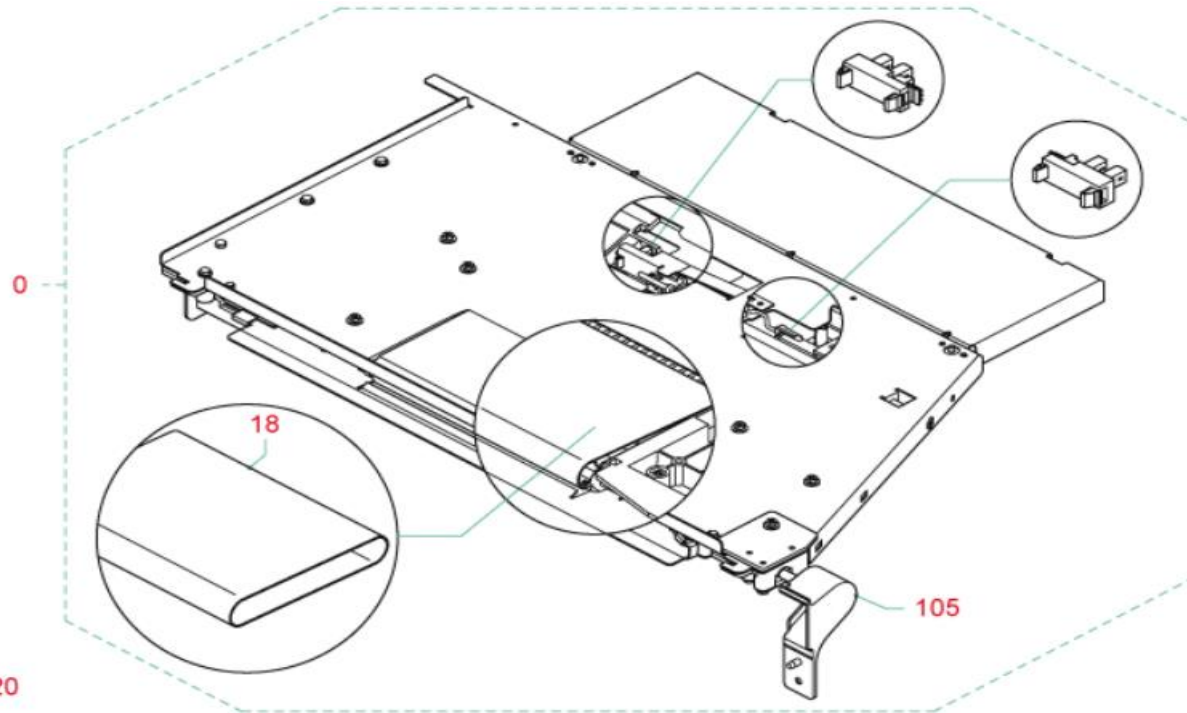
Separation Unit

Index	Part no	Qty	Description
0	1070112123	1	UNIT,SEPARATION -SERVICE
105	7133382	1	CAP, PULLEY

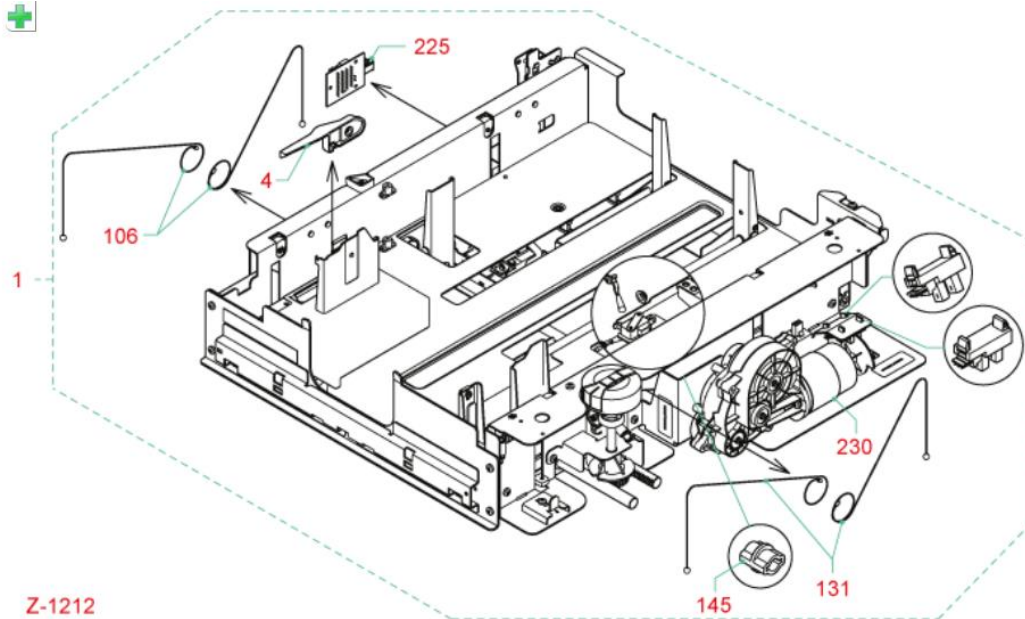
## Paper Tray Small

Index	Part no	Qty	Description	Note:
1	1070037090	1	PAPERTRAY,SMALL (PACKED)	
4	1060124364	1	LEVER (PACKED)	
106	1070126481	2	CABLE	
131	1070126481	2	CABLE	
145	1070091960	1	BUSH	
225	1060113792	1	PBA,TRAY_DISTRIBUTION (PACKED)	
230	1070012567	1	DRIVE UNIT PACKED

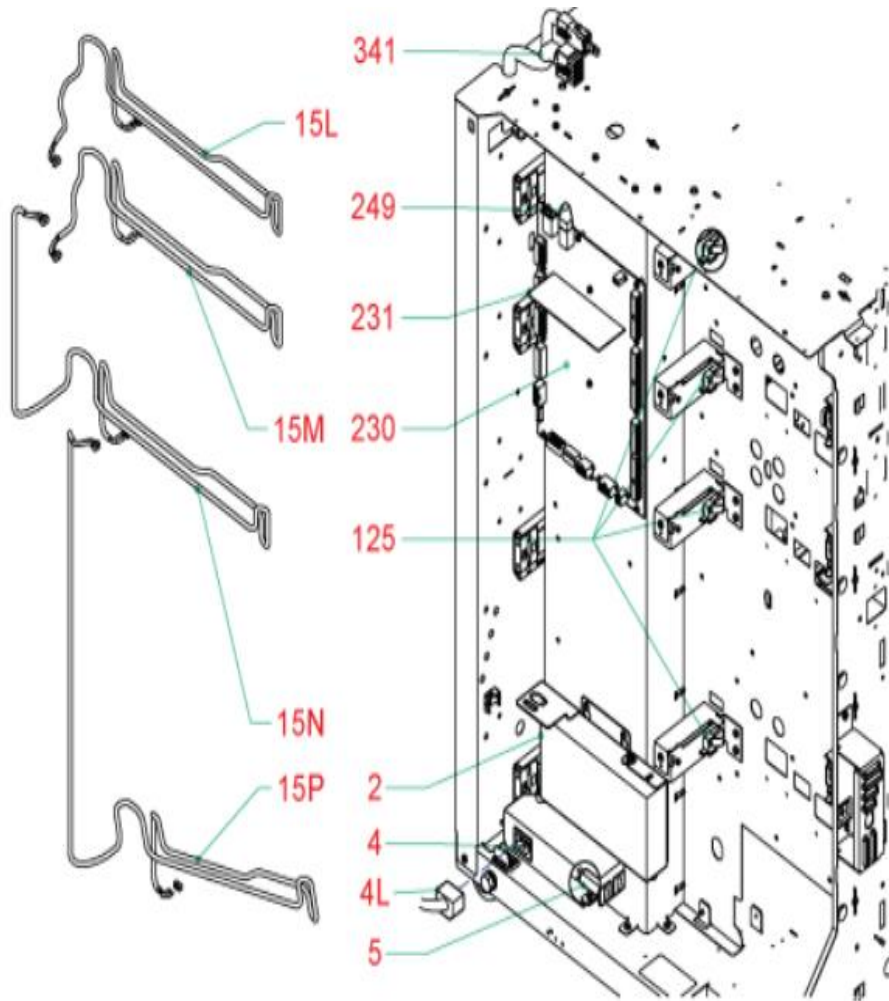
Power Supply Assy / Electrical

Index	Part no	Qty	Description
2	1070033971	1	POWER-SUPPLY-CPL (PACKED)
125	1040501	4	SWITCH,MICRO -1X2P
230	1070009194	1	PBAP,EPIM (PACKED)
231	1060121976	1	PBAP,SPIDER CORE

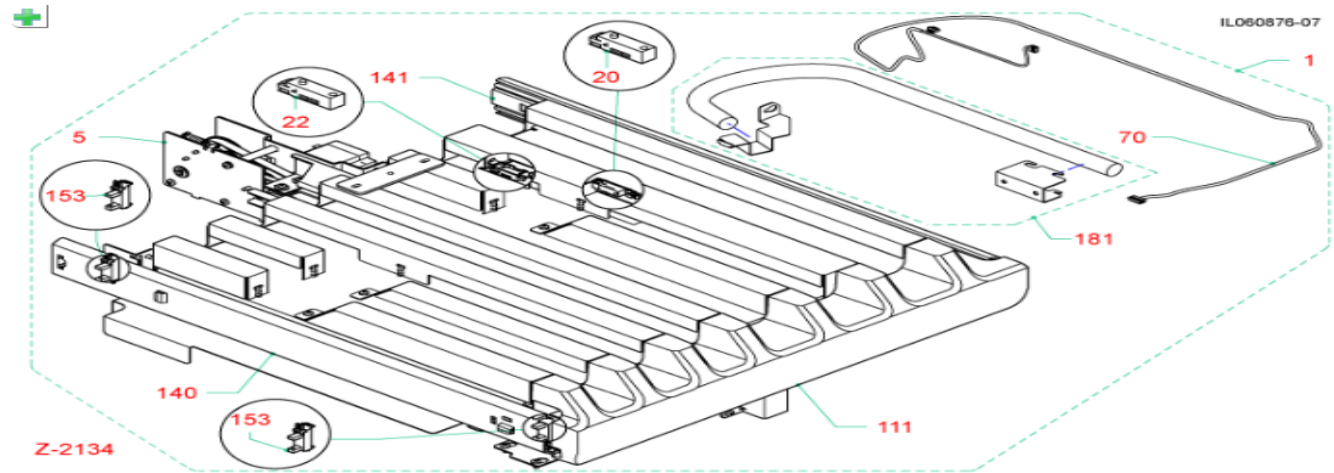
Z-2134

Index	Part no	Qty	Description
1	1070122516	1	TABLE EJECT -SERVICE
5	1070099764	1	DRIVE EJECT
20	1060026381	1	SENSOR, REFLECT, SWITCH MR=0.5-6.5MM
22	1070034702	1	ENCODER, OPTICAL REFLECTIVE PAN MDD=22MM
70	1060125956	1	HARNESS, 21W03
111	1060126141	1	BUMPER
111	1070110827	1	DOOR,FRONT PIM
140	1070099317	1	RAIL,LEFT
141	1070099319	1	RAIL,RIGHT
153	1201400	2	SENSOR,OPTO SLOTTED 15-2 PAN
181	1070078888	1	MOD3, SLEEVE- TABLE EJECT

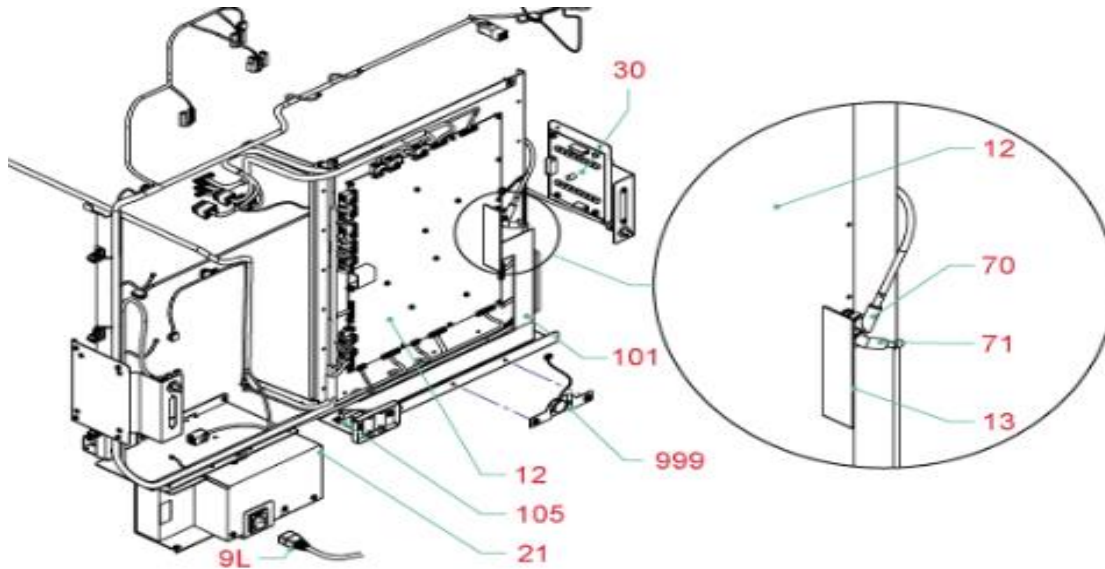
Index	Part no	Qty	Description	Note:
12	1070120436	1	KIT, PBAP STACKER_SPIDER_IO	- Only for HCS F1 and HCS G1. - varioPRINT 135 series: SW R2.5 or later is needed. - imagePRESS C7010 VP (S) series: SW R2.2 or later is needed. 21PBA02
12	1070091583	1	PBAP,STACKER_IO_NOARCNET	Only for HCS H1. 21PBA02
13	1060121976	1	PBAP,SPIDER CORE	21PBA09
21	1070103710	1	POWER SUPPLY UNIT (SERVICE)	
30	1060033261	1	PBA,DFD IF
